Application: 72" Brick Sewer

Client: DC Water

CASE STUDY:

72" Brick Sewer Washington, D.C.

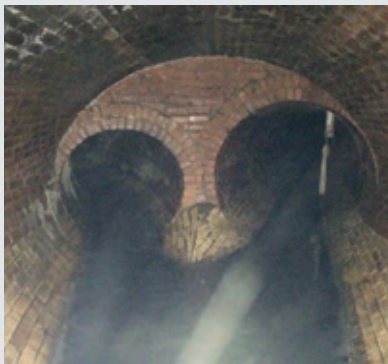
The most severe damage was located between 11th and 12th Streets, where the crown was cracked and missing bricks. Fortunately, there was no significant oval deformation, and there were not many open mortar joints, which would be typical of an impending pre-sink-hole collapse scenario.

Initial brick sewer condition.

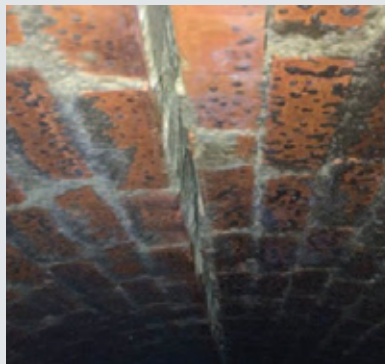
Close up of damaged brick crown.

The rehabilitation required a 50-foot full structural repair section that was missing bricks and showing signs of advanced crown deterioration and a 125-foot long partially deteriorated section that needed to stop inflow and infiltration and provide some structural support to the bricks and missing mortar. After further inspection, DC Water requested a change order for a full structural repair of the entire 175-foot.

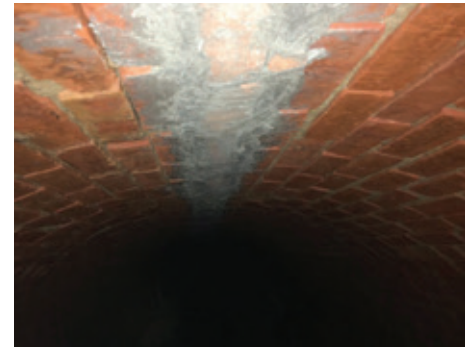
Grouted repair of cracked crown.

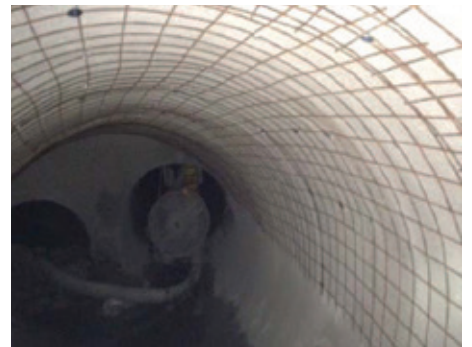
Welded wire mesh placed across crown of pipe after initial GeoSpray application.

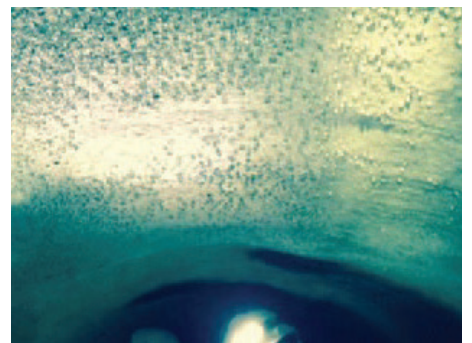
Completed project.
