GEO SPRAY®

CASE STUDY:

Tireman Avenue Detroit, MI

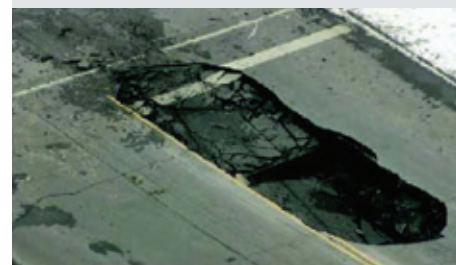
In May 2016, a massive sinkhole formed underneath Tireman Avenue in Detroit, Michigan. The root of the problem was a fractured sewer line. A damaged pipe leading to a major concrete interceptor caused heavy infiltration, which in turn resulted in soil loss around the interceptor at the fractured location of the pipe. The soil loss eventually worked its way to the surface to create a 12-foot wide sinkhole, forcing the closure of Tireman Avenue and major public disruption. The pipe was directly below multiple utilities, including a 16-inch high-pressure gas main. If the interceptor totally failed, then the utilities were at risk of catastrophic damage.

Sinkhole on Tireman Avenue caused by damaged interceptor.

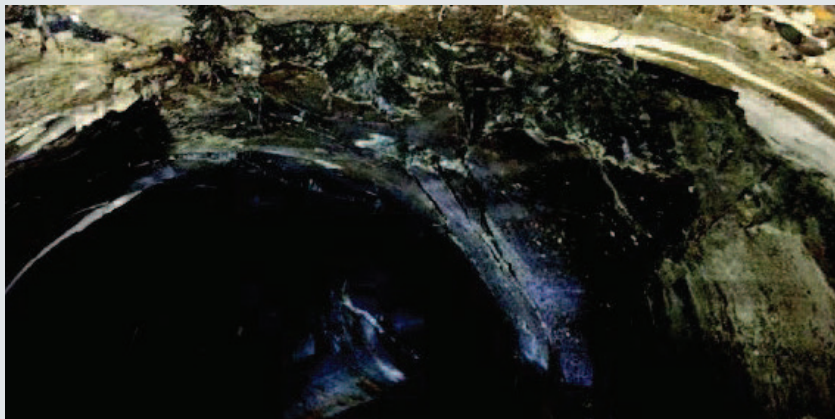
The 1930's design had the flow from the connection emptying near the crown of the interceptor, and this vertical drop created turbulence and ultimately the formation of H₂S gas, which ate away at the secondary liner. This corrosion was discovered when the sinkhole appeared, but had been corroding for decades.

Damaged and corroded sewer interceptor under Tireman Avenue.

The straight section of the interceptor was repaired with a 78-inch HOBAS pipe. The curved portion of the interceptor, however, made it unsuitable for this type of rehabilitation. IWPC proposed and designed an alternative repair, which included the installation of conventional "I" section ribs with tie rods for reinforcement followed by the application of GeoSpray® geopolymer mortar as a preferred structural repair solution for this section of the project. When the area had been cleaned, relined and grouted, GeoSpray® mortar was sprayed onto the new ribs and lagging. Grade nails were installed to verify the specified 1.75-inch thickness required for the curved portion.
