RENEWWRAP®

Carbon Fiber Strengthening System

Case Study Reinforced slab and beam, Southeastern U.S.

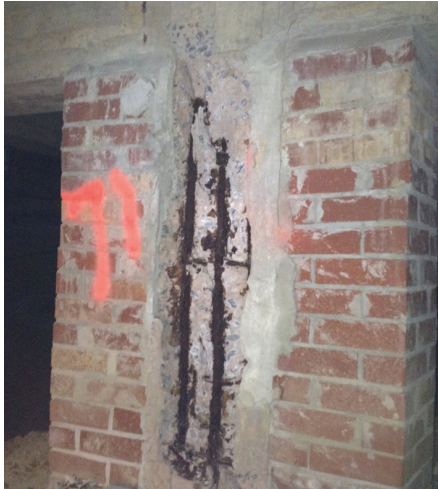
More than 100 years after initial construction, a textile plant in the Southeast serving the booming automotive industry discovered it needed to rehabilitate portions of the structure supporting the main manufacturing floor. Years of exposure to the hot, humid manufacturing environment and chlorides used in the manufacturing process had taken a toll on reinforced concrete beams and columns supporting the concrete slab. Significant corrosion-related damaged had weakened the beams and columns.

Deteriorated column prior to repair

Damage to the concrete columns was repaired by removing the loose concrete and, where possible, replacing some of the lateral tie reinforcement. Once the columns were patched using a traditional concrete repair mortar, the columns were wrapped with the RenewWrap carbon fiber reinforced polymer (CFRP) strengthening system to restore any remaining deficient tie steel.

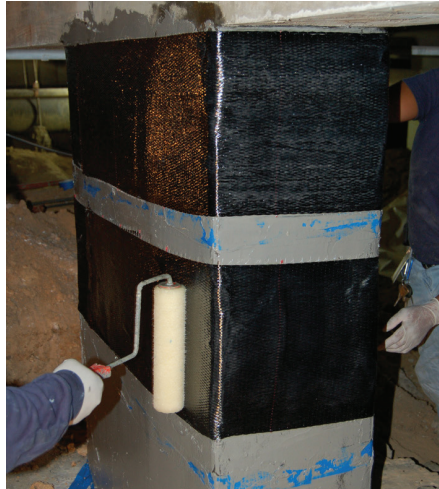
Applying RenewWrap FRP to confine column

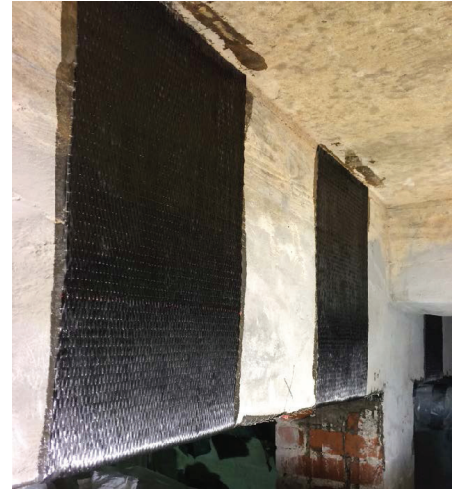
RenewWrap U-wraps for shear

Once OCS completed shoring installation they began making repairs to the beams by removing the loose concrete with small chipping hammers, cleaning and replacing, where possible, the corroded reinforcing steel, and restoring the cross-section of the beam with traditional repair mortar. After the repair mortar cured, RenewWrap carbon fiber was applied to the bottoms of the beams to provide additional flexural strength and U-wraps were bonded to the sides of the beams to provide additional shear strength especially in locations where supplemental masonry columns had been constructed years ago to shorten spans.

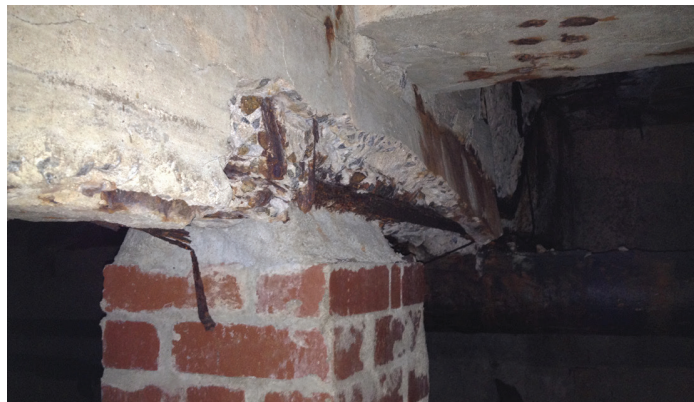
The reinforced concrete beams presented numerous challenges due to the level of deterioration and difficult access within the 4-foot crawl space containing numerous pipes. Early repair/strengthening proposals included removing the existing beams and pouring new, reinforced concrete members and installing supplemental steel beams on either side of the deteriorated members. Both options were difficult to implement without working from the top side and disrupting the manufacturing operations. The “tried-and-true” approach of installing supplement steel beams was impractical to implement.

Deteriorated beam prior to repair

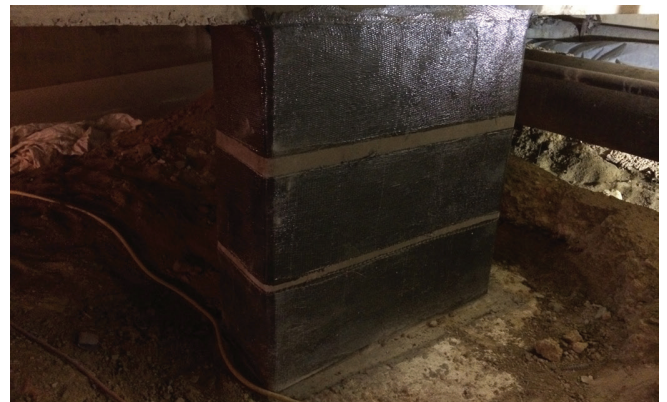
Completed column

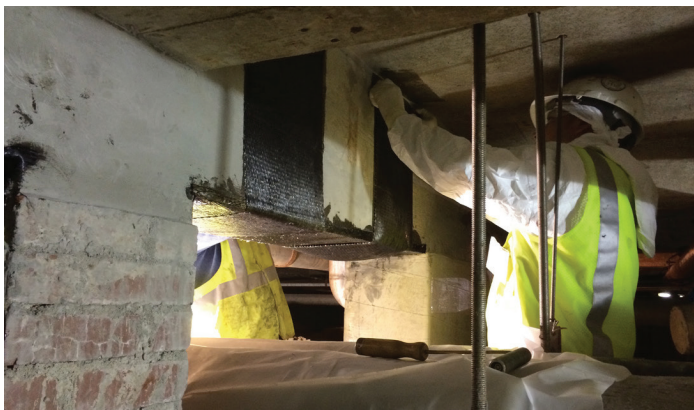
Installing U-wraps

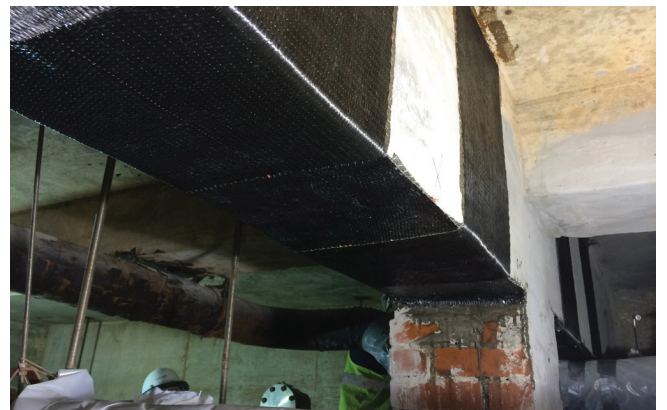
Flexure plies and U-wraps
