Atlas Repair of Complex Air Interface Process Lines Remediates External Corrosion

Colombia

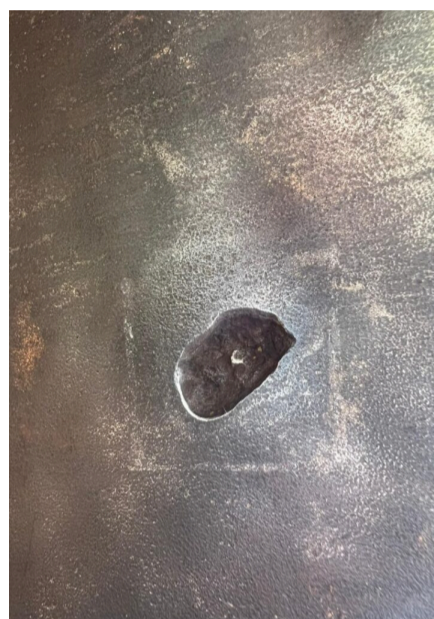
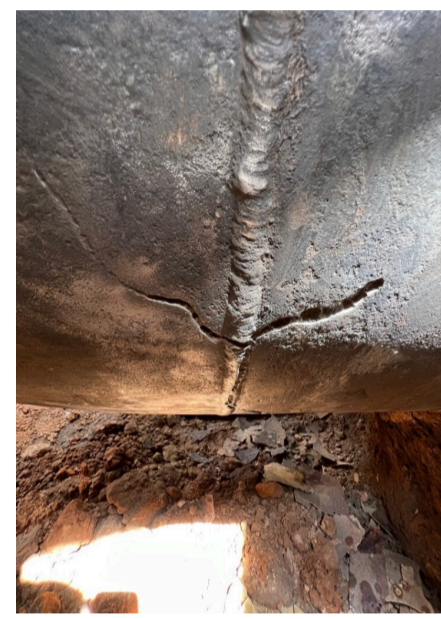
Inspection revealed damage from external corrosion on process lines in the injection water transport system.

Severe external corrosion was identified on each of the six elbows slated for repair, all of which were part of the injection water transport system. The wall thickness losses were up to 50% in some areas. Repair was engineered to accommodate a wall thickness of 0.375 inches with an operating pressure of 285 psi and a temperature of 60°C (140°F). Both the locations and geometries were challenging to access. Atlas is a flexible composite repair system that adapts well to complex deformations and is ideally suited to application in areas of low clearance. With no need for hot work, it was possible to keep the pipeline operational, as any interruption would incur additional costs in time and operation.

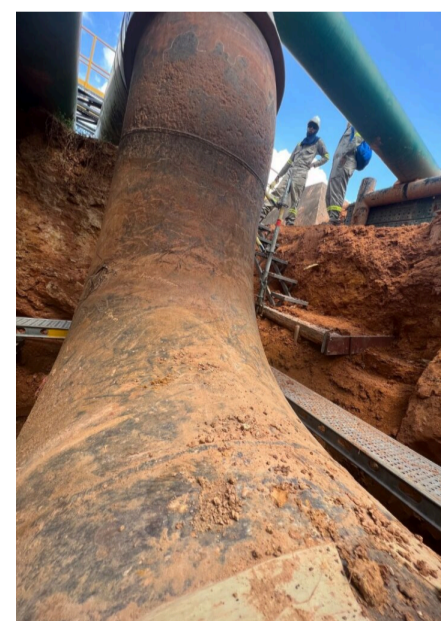
Exterior corrosion and difficult access to elbow geometry posed challenges to repair of six process lines.
