# Testing Validates the Use of Atlas for Restoration of Extensive Wall Loss

Colombia

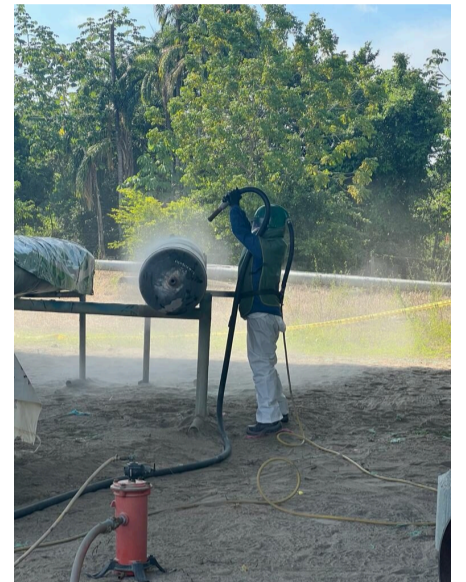
*Prior to the repair, the surface was prepared to near-white metal via media blasting.*

To repair the defect, Aplika Control Corrosión prepared a 36-inch surface area with abrasive blasting according to the SSPC-SP 10 near-white metal cleaning method. The anchor profile was measured at random points in the installation area, ensuring a minimum profile of 60 microns on the surface and permissible minimum environmental conditions for proper installation (RH < 90% and temperature variation > 3°C).

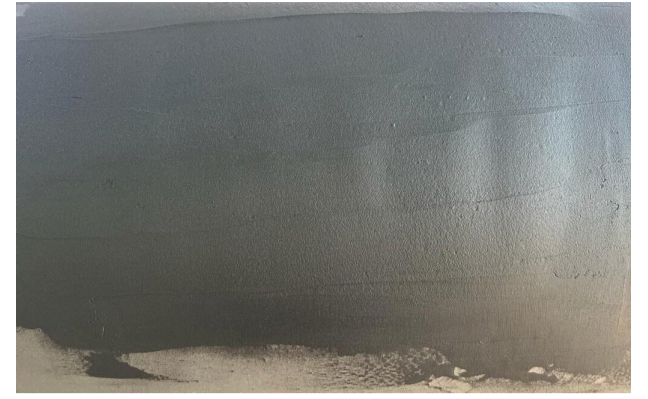
*The pipe geometry was smoothed with EPN 242 putty prior to the application of the Atlas wrap.*

Next, EPN 242 putty was used to rebuild the geometry of the pipe and ensure uniform load transfer. PPR 290 adhesive primer was applied as a corrosion inhibitor, followed by a layer of fiberglass impregnated with SFE 206 using the two-layer offset method.

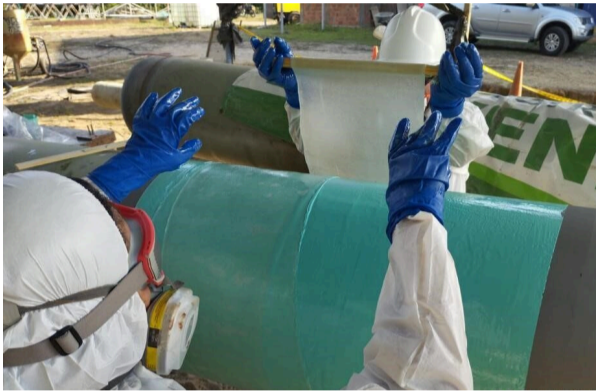
*Fiberglass impregnated with SFE 206 was applied over the PPR 290 primer.*

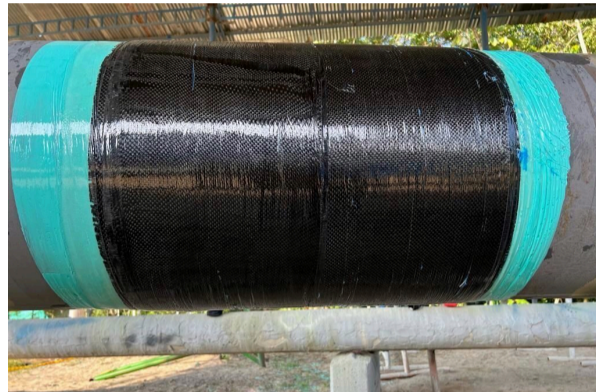
*Next, 12 layers of Atlas were applied in an offset manner.*

Based on the operating conditions of the line and the characteristics of the defect, an installation of 12 layers of Atlas composite material was applied using the offset method, covering a repair length of 24". A compression film was used to cover the repair area, allowing for curing after perforation.

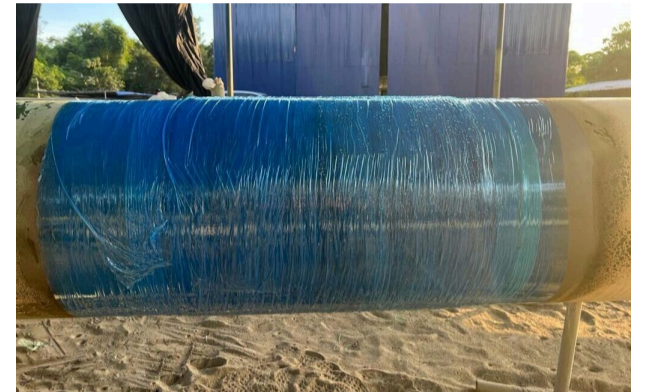
*Compression film was applied over the repair and perforated, then allowed to cure.*

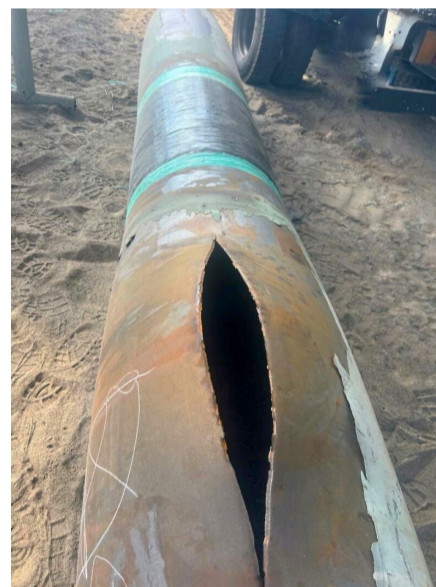
After cycling, the test specimen with the Atlas composite system was subjected to a burst test. The objective was to evaluate the performance of the Atlas repair system and study the impact of internal pressure on the repaired specimen. The results revealed that the reinforced specimen, exposed to over 2800 psi, exceeded design expectations by over two times, as the failure occurred outside of the repair zone.

*The repair was tested to 2800 psi, resulting in a failure to the pipe body, but not to the Atlas repair, which was designed for 1200psi.*

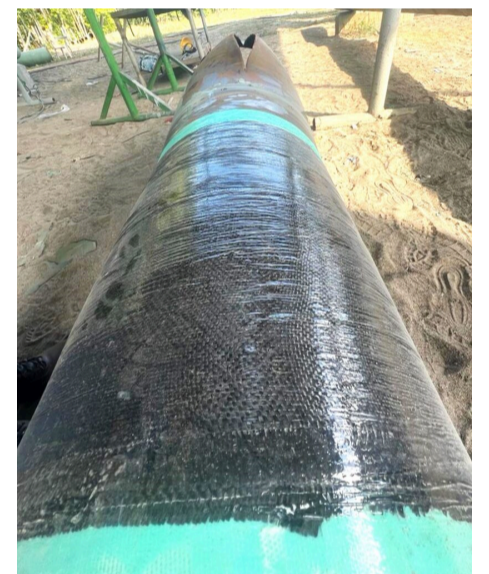
The test demonstrated that the Atlas composite system had the best performance in burst tests and strength compared to other evaluated systems available in the Colombian market, ranking first for non-metallic reinforcements with thickness losses of up to 80%.

*The burst test revealed that the Atlas system outperformed all other non-metallic reinforcements for repairing pipe with wall loss of up to 80%.*
