STRUCTURAL STRENGTHENING OF PLINTH WITH FRP AT A UK REFINERY

- **Application:** Concrete plinth Strengthening
- **Location:** South UK, refinery
- **Installation:** CSNRI UK service team

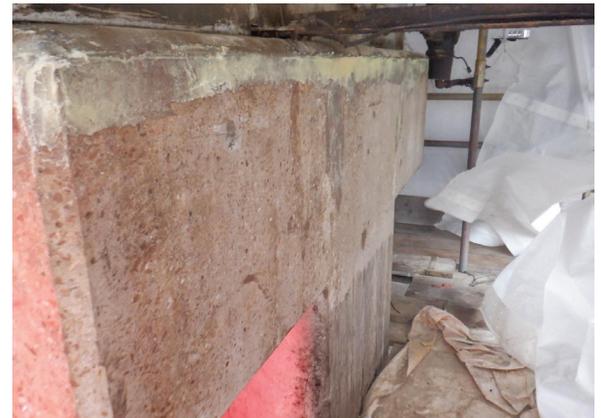
The 8ft by 2ft plinth was suffering from corrosion which included shear cracks where the plinth's T-beams met the column, spalling concrete and steel corroding at several locations on the reinforced concrete structure.

Surface prepared, cracked and damaged areas filled

The work involved thoroughly cleaning the concrete structure of loose debris, and the filling of any cracked and damaged sections. The FRP was then applied using the wet layup method, which sees the FRP material thoroughly saturated with epoxy before being applied to the surface.

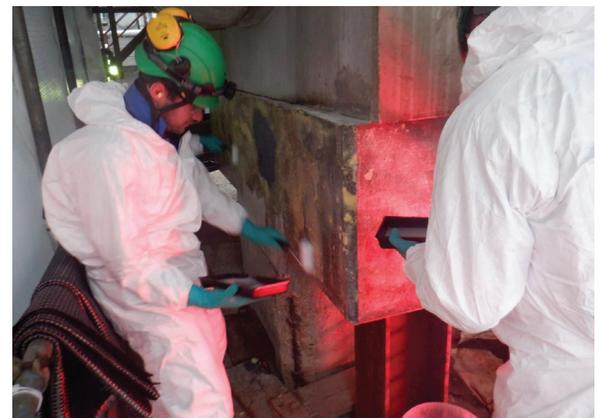
Tyfo S applied to the surface area

The rehabilitation work included the application of the Tyfo SCH-41 uni-directional carbon fiber-reinforced polymer system oriented in both vertical and horizontal directions on both faces of the plinths. The shear capacity provided to the structure by the Tyfo SCH-41 system was calculated per ACI 440.2R-17, Guide for the Design and Construction of Externally Bonded FRP Systems for Strengthening Concrete Structures.

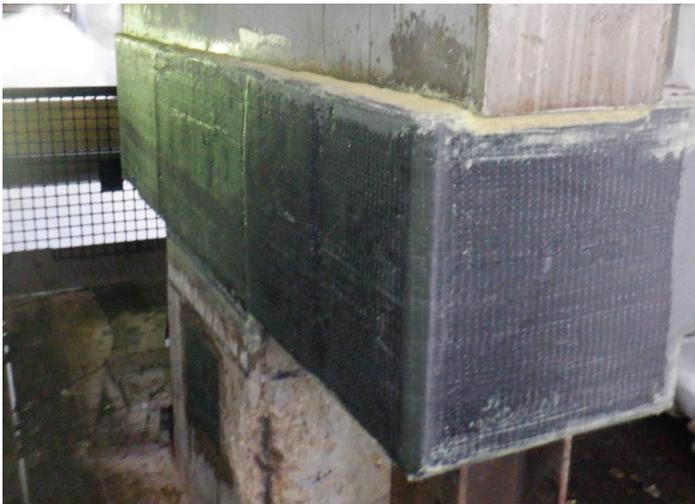
Horizontal layers applied

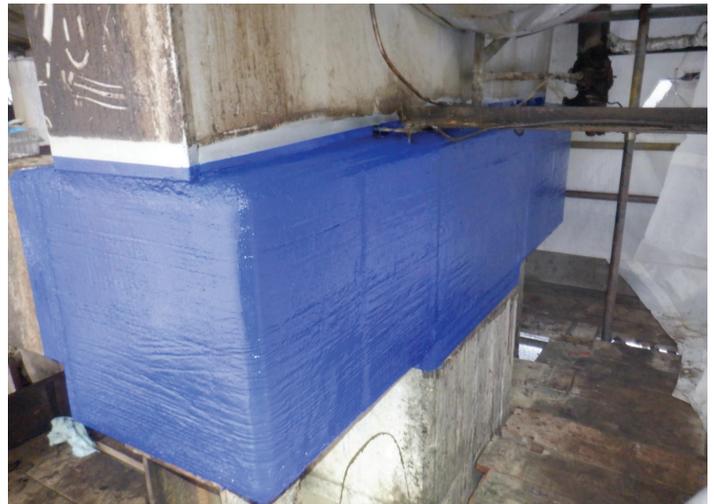
Completed installation

In all, the CSNRI team took eight days to complete the repair.
