# Clock Spring Repairs Mechanical Damage from Alkaline Soil Erosion

Indonesia

### Pipe Details

- 28-inch (711-mm) diameter
- 2 bar (1,050 psi) operating pressure
- 27° C (81° F) operating temperature.

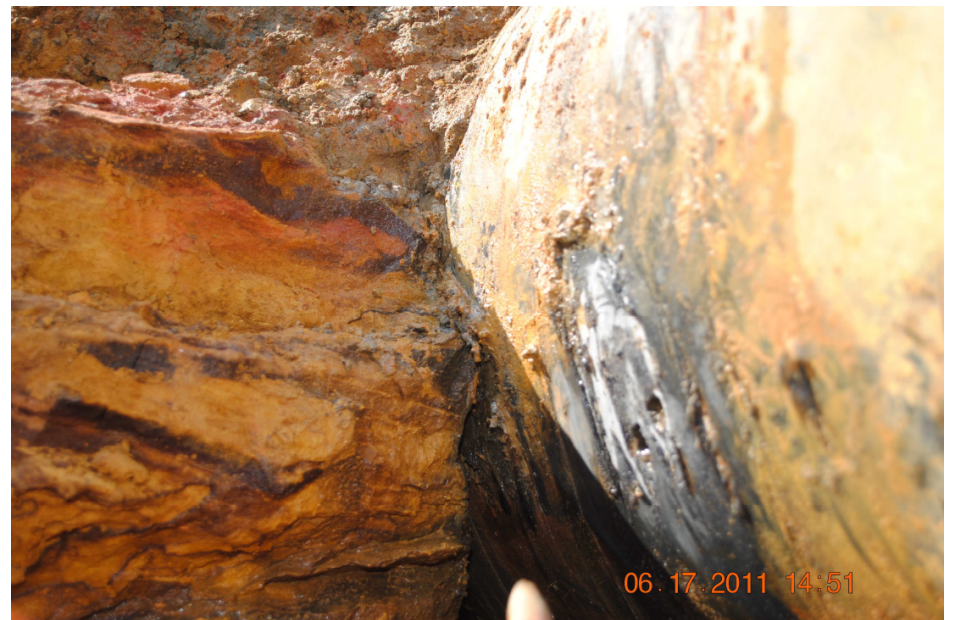
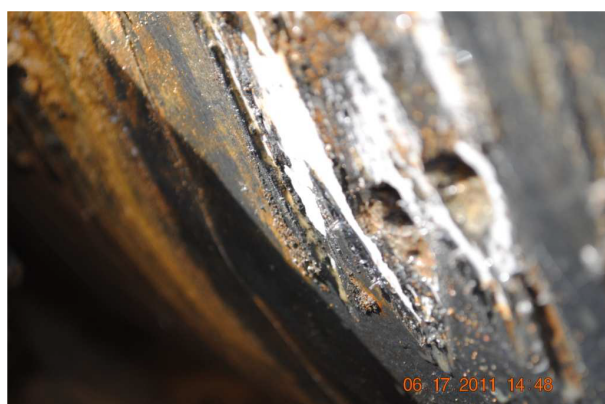
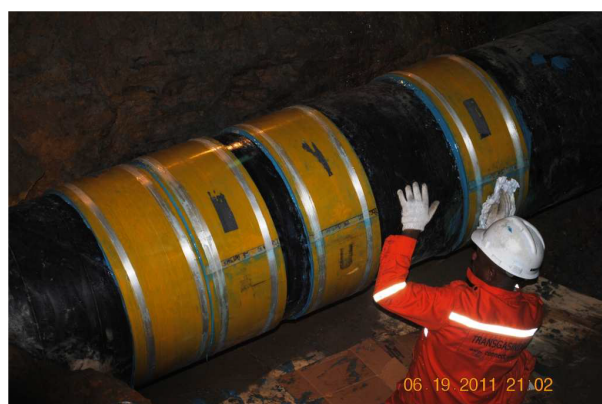
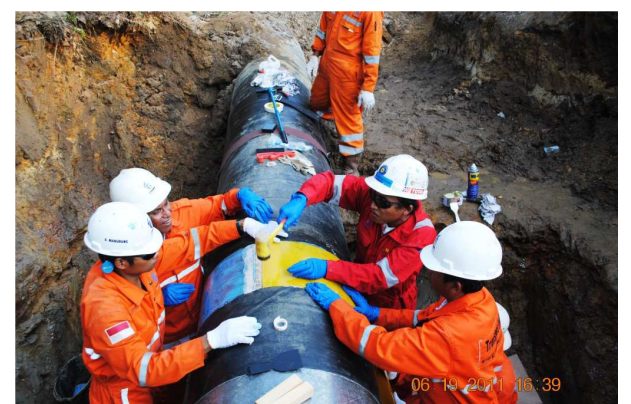
An inspection team in Indonesia discovered external pipe defects caused by alkaline soil on a section of buried 28-inch (711-mm) pipe.

The erosion had resulted in significant mechanical damage. The asset owners wanted an immediate repair that would allow them to restore the damaged line to a safe operating condition.

*alkaline soil erosion*

Following excavation, a Clock Spring trained and certified team of installers manually prepared the pipe surface for a Clock Spring sleeve repair designed to reinforce the weakened section of pipe.

The installation team installed 4 Clock Spring repair sleeves under the supervision of a Clock Spring Supervisor, restoring the line for safe operation within a single day.
