Composite Repair of a Vertical Knock-Out Drum

Singapore

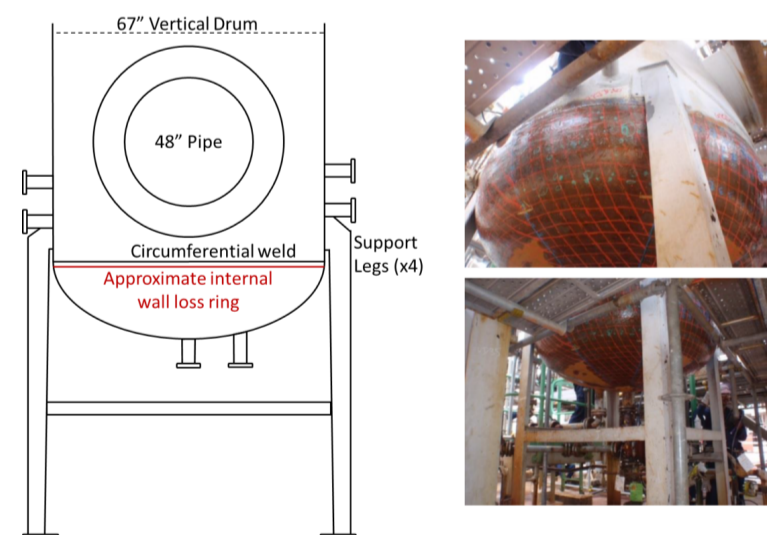
Figure 1: Sketch and view of Vertical Drum prior to Repair

- Leaking Vessel - localized areas were expected to quickly reach through-wall conditions.
- Structural Failure - As can be seen in reference Figure 1, the support structure for this knock-out drum connects above the affected area. If sufficient wall loss occurs beneath this support, the bottom dome will detach causing severe structural failure.

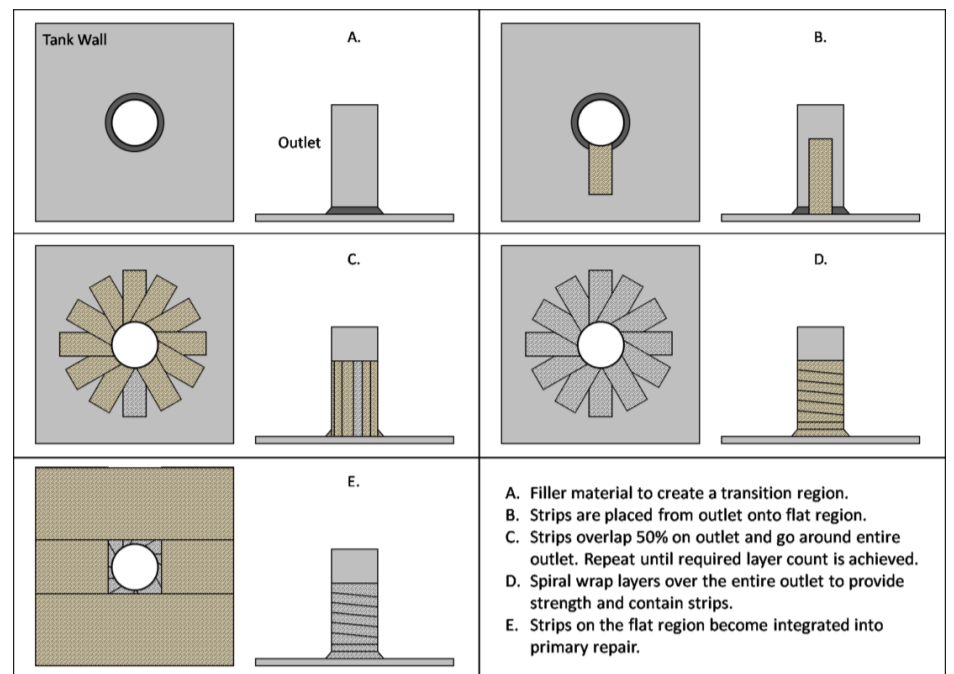
Figure 1: Visualization of nozzle tie-in procedure

There were many outlets over the intended repair region that required a “tie-in” to ensure a consistently strong repair area. Generally, a smaller fabric width was utilized on these nozzles to provide structural support to the nozzle itself as well as to create a tie-in region. The drawings below show the general path taken for the nozzle tie-ins referenced throughout the remainder of the installation.

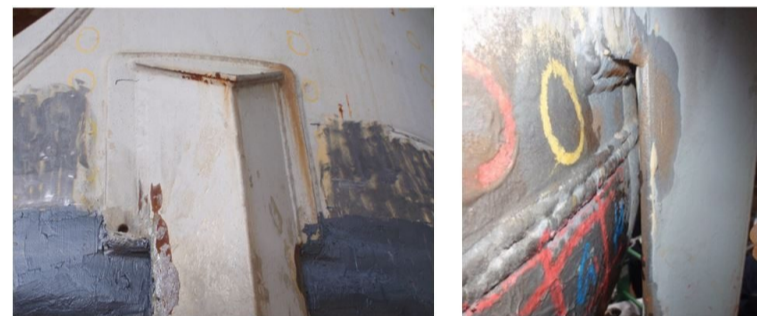
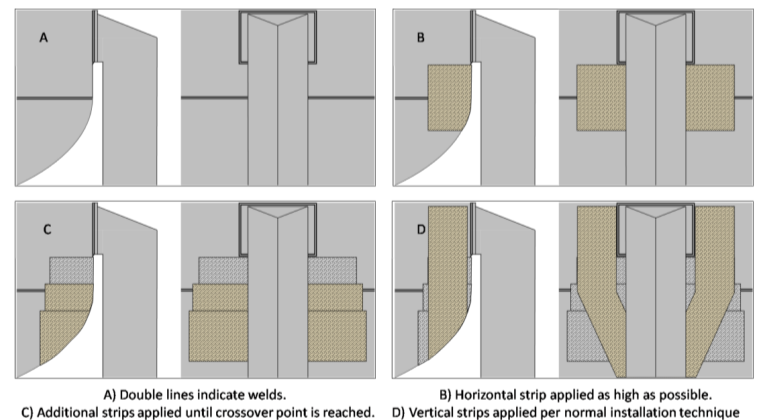
Figure 2: Visualization of leg support procedure

The construction and placement of the support legs provided a unique challenge in the installation due to the limited space available. The support leg was welded to the shell about 2-3 inches above the dome weld and 4-5 inches above the internal defect. Near the dome weld, only an inch of clearance was available. Ensuring a consistent, strong repair underneath the support leg was critical to the overall success. Throughout the various installation steps, a different procedure had to be followed to tie in the area beneath the support leg. After the initial four layers of FormaShield™ were vacuum bagged underneath the support leg, all the remaining layers were applied via vertical strips running up and down the drum. In regions covered by the support leg, this was not a possible and an alternate method of achieving the desired layer count had to be used. Primarily, short horizontal strips were placed underneath the support leg in a stacked sequence to achieve the required layer count. Vertical strips, per the original installation method, were then used to capture the horizontal strips securing them in place. Figure 2 shows images of the support leg as well as an example installation procedure.
