Contour Composite Repair Restores Offshore Firewater Line

West Africa

Pipe Details

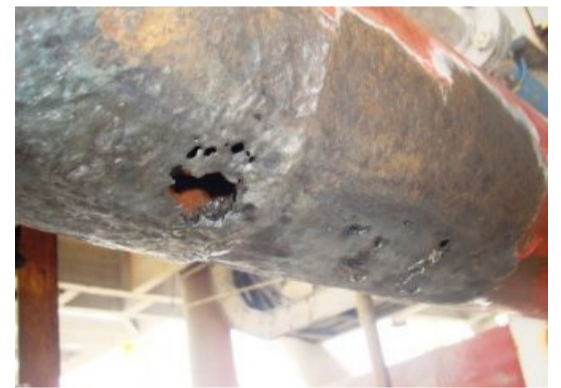
Workers on an offshore platform discovered multiple through-wall defects at a bend on the main firewater line when they pressurized the line and it failed. The decision was made to repair the line immediately to mitigate the risks associated with a compromised system.

Corrosion led to multiple through-wall defects on an 203-mm (8-in) diameter firewater line on an offshore platform.

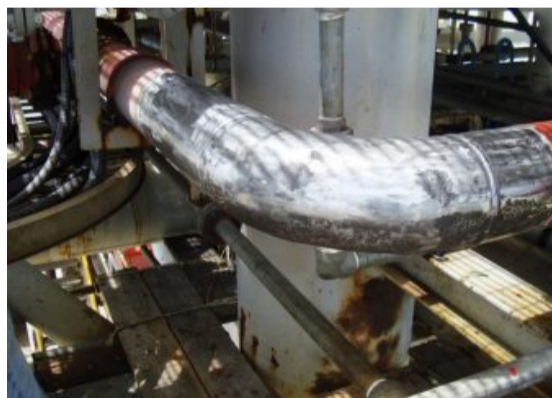
Installers used power tools to clean the spool sections in preparation for the composite repair.

Clock Spring trained and certified installers moved to the installation site to execute the Contour repair, removing the coating on the damaged line using power tools and using a bristle blaster to produce the required surface profile, equivalent to SA2.5.

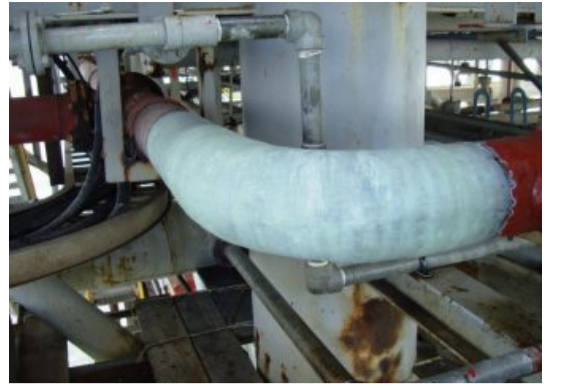
A Contour composite repair restored the damaged line to safety.

With the line prepared, installers applied a Contour repair designed in accordance with ISO 24817, which outlines requirements and recommendations for qualifying, designing, installing, testing and inspecting the external application of composite repair systems to corroded or damaged pipework, pipelines, tanks, and vessels used in the petroleum, petrochemical, and natural gas industries.

Following the established installation process, the team applied filler material to the holes, followed by epoxy and quad-axial stitched fiberglass cloth.
