DiamondWrap® 4" Internal Corrosion High Pressure Repair

TEXAS, USA

Pipe Details

- 4" pipe
- 2,350 psi
- Temperature: 375oF
- Urea Offgas From Stripper
- Internal Corrosion

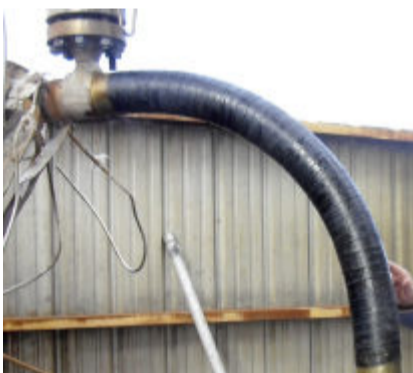
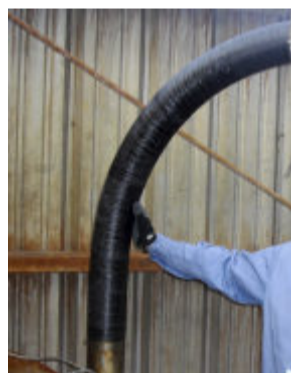
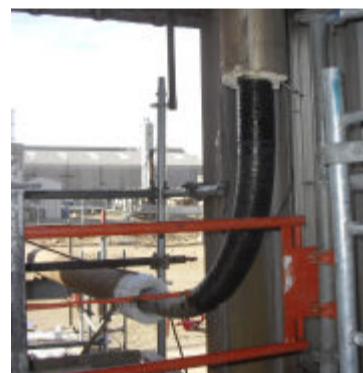
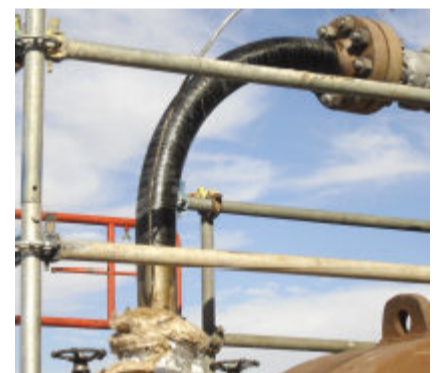
A plant in Texas came to CSNRI with internal thinning occurring on a 4" diameter long-radius elbow with Urea offgas flowing from the stripper. At a high pressure of 2,350 psi, thinning pipe is at danger of explosion. Agrium was in a tight spot as the temperature was higher than most composite repair systems could handle, and a clamp would have been too heavy and expensive to fabricate. Overall, 4 different elbows required repair.

CSNRI team of engineers designed a repair according to ASME PCC-2 Article 4.1, and recommended a DiamondWrap® repair solution. Only two layers of the high-strength DiamondWrap® composite repair system was required to repair the 4" long-radius elbows.

A team of trained and certified installers applied 2 layers of carbon fiber over the specified repair area of each elbow, according to the calculations prepared by CSNRI engineers. The repair cured within 24 hours. The unit did not have to be shutdown while the repair was installed, saving the customer time and money.
