PROJECT OVERVIEW

Location: Glen Eden,
Auckland, New Zealand

Application: Storm Sewer
Rehabilitation

Client: Auckland Council

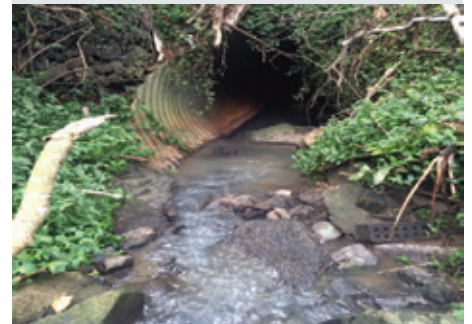
The city of Auckland, as with many other parts of New Zealand and around the world, have utilized galvanised corrugated iron culverts as part of the drainage network. Typical installations are to enable roads and rail to costeffectively traverse creeks, streams and small rivers. The original purpose for the installation of the Kashmir Road culvert is not entirely clear but could have been to improve residential development opportunities or to address streambank erosion that may have threatened an existing residential dwelling. Whatever the previous reasoning for its installation, nearby residential dwellings were under threat due to the looming collapse of the 1.8 meter (70 inches) diameter culvert as a result of eroded ground support and missing culvert invert for the majority of its 30 meter (98 feet) length. The local council was concerned that failure of the pipe could destabilize adjacent land and cause flooding of neighboring properties.

Kashmir Road culvert prior to GeoSpray mortar rehabilitation.

Reinstatement of lost culvert invert using premixed concrete to reduce some culvert collapse risk. Installation of centrifugally cast geopolymer mortar inside an old pipe to provide fully structural rehabilitation. Minimised risk to local residential dwellings. Ability to perform with minimal disruption to local residents. Environmentally friendly due to product being inert once cured.

The Council chose GeoSpray geopolymer mortar due to the lower installation cost, limited disruption to local residents, environmental credential and performance. The city did not choose open cut due to cost, difficulties with machinery access due to site constraints, disruption and noise.

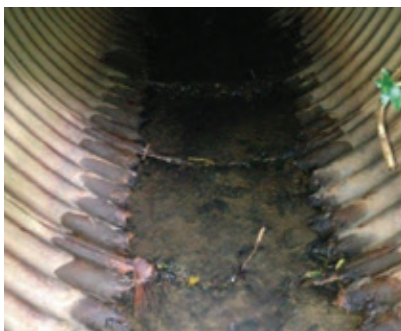
Initial pipe conditions were extremely poor.

Day 2: Setup temporary by-pass, including upstream dam and three-stage downstream sediment traps, to protect stream. Remove woody debris and river stones. Clean culvert using high pressure water blasting equipment.

Day 3: Install concrete fill to reinstate culvert invert.

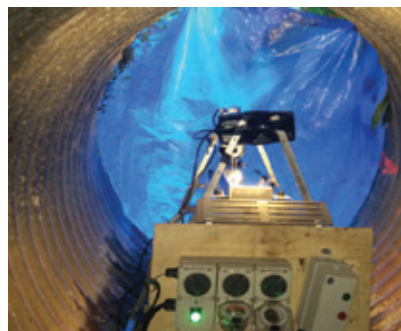
Spin casting application of GeoSpray mortar to existing CMP host pipe.

Day 4: Setup GeoSpray mortar truck and ancillary equipment and apply first coat of GeoSpray mortar to 30 meters (98 feet) of culvert and allow to set.

Day 5: Apply second coat of GeoSpray mortar to 30 meters (98 feet) of culvert and allow to set.

Day 6: Apply final coat of GeoSpray mortar to culvert.

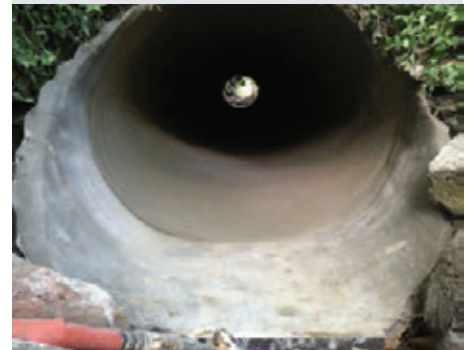
Kashmir Road culvert after GeoSpray mortar rehabilitation.

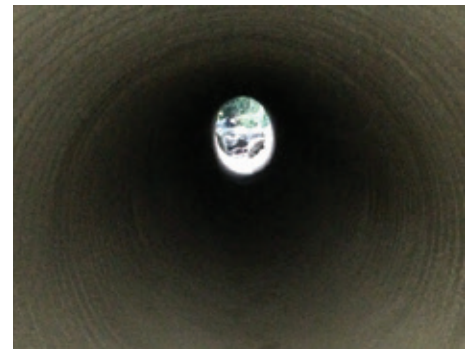
Completed pipe.
