Ft. Bragg, NC CMP Culvert Rehabilitation

CASE STUDY:

CASE STUDY: Ft. Bragg, NC CMP Culvert Rehabilitation

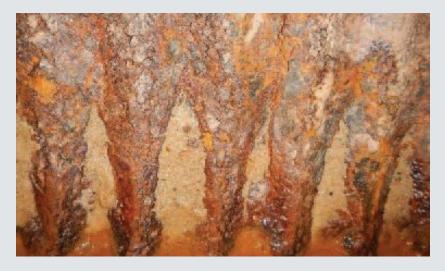
Corroded culvert prior to rehab.

Inland Pipe Rehab was selected as the contractor for the project. The design thickness specified by USACE was two inches of GeoSpray geopolymer mortar as the repair lining. The application was performed with temperatures in the 40 °F range and was applied in three application passes.
