Testing Program Validates Wrinkle Bend Repair Solution

By **Tim Mally, ClockSpring|NRI**

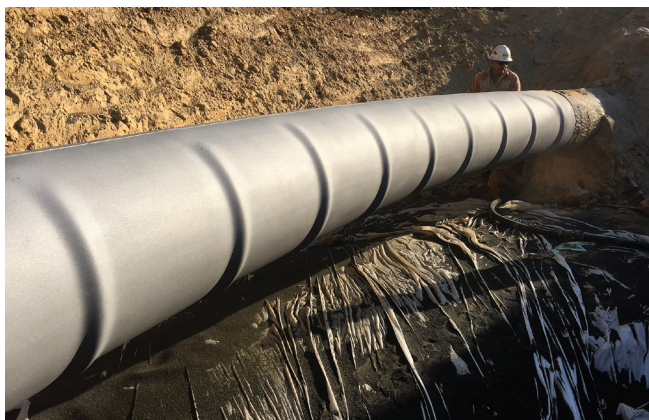
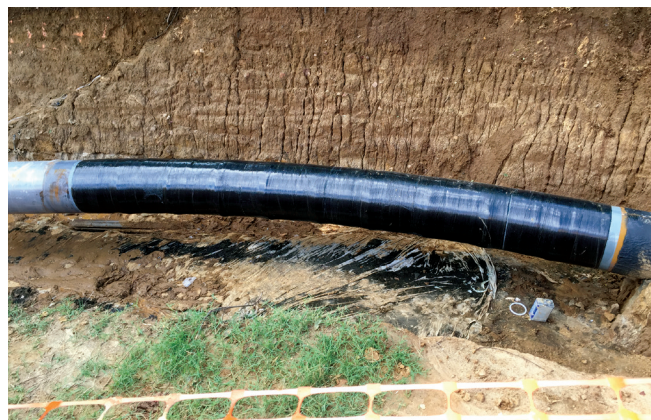
Composites provide quality repairs that can be installed quickly for reliable results. (Photos by ClockSpring|NRI)

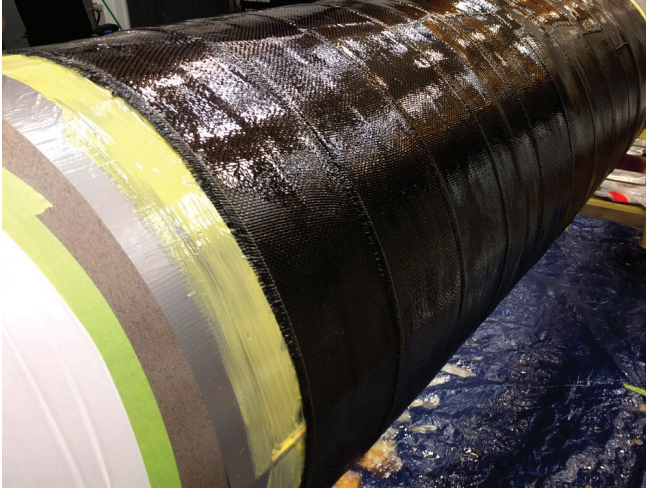
A piece of pipe was covered with the new proprietary composite design to undergo laboratory tests to determine its durability.

In the subsequent test, a piece of pipe was covered with the new proprietary composite design with a thickness of 0.43-inch (10.9 mm) using an installation technique that decreases application defects by addressing application inconsistency.

This specimen was subjected to 1,340 bending cycles before the composite failed. This represents an increase of almost 600 bending cycles over the composite repair designed for the original study. Additionally, the average axial strain range at the wrinkle decreased from 4,997 $\mu\epsilon$ in the original experimental study to approximately 4,000 $\mu\epsilon$. The decrease in axial strain directly reduces the calculated effective SCF from 2.4 to 1.8.
