## RenewWrap FRP with EZ-Slit employed to reinforce Nicaraguan bank structure

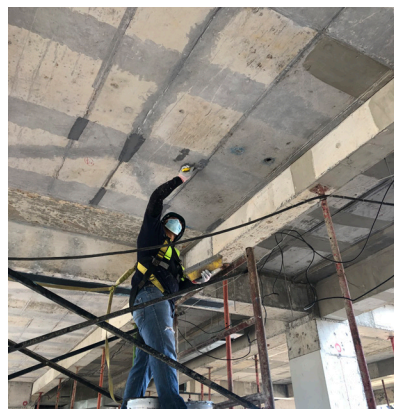
RenewWrap EZ Paste applied

The repair process involved clearing out the cracks and spalling areas before applying RenewWrap EZ Paste. This filled the bug holes and imperfections to the concrete creating a stable substrate.

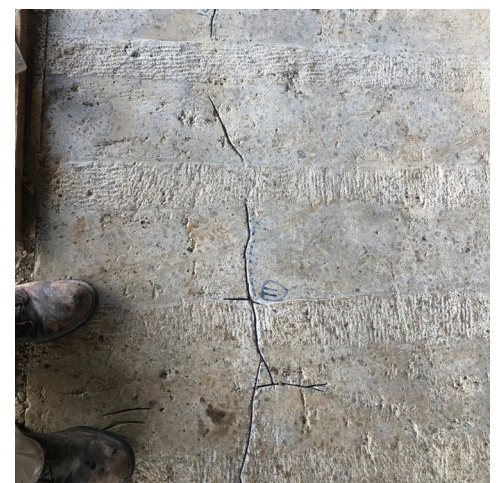
A large building was in the process of being constructed when a 6.1 magnitude earthquake struck. Following inspections, cracks and other structural issues were discovered that needed to be addressed before the remaining construction could take place.

Cracked and spalling concrete

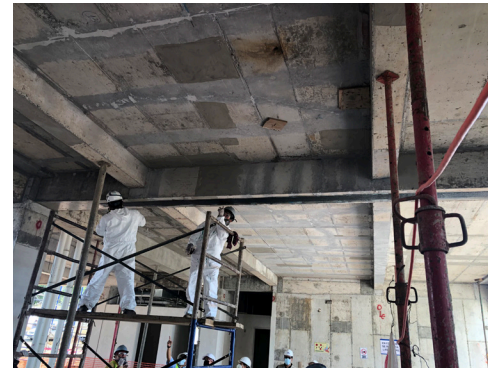
*RenewWrap installation*

ECAST applied 4800 sqft of RenewWrap CF600 complete with EZ-Slit functionality. EZ-Slit allowed the contractor to make cuts in the material at 6" and 12" intervals without being concerned with the fraying that occurs with FRP materials from other suppliers. EZ-Slit delivers better efficiency, improved quality, and less waste.

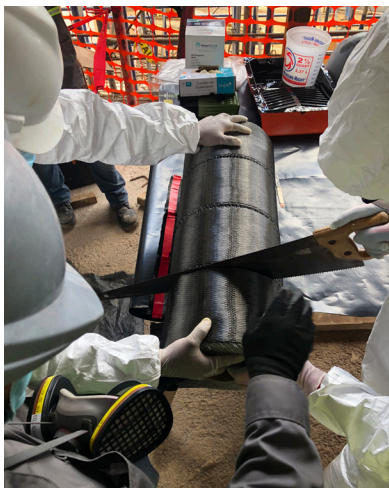
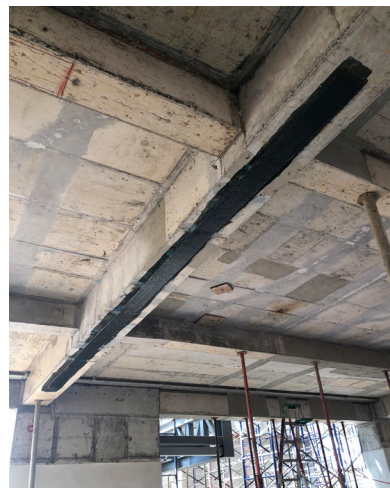
*RenewWrap EZ-Slit FRP - cut to size      Ready-cut widths of RenewWrap in place*

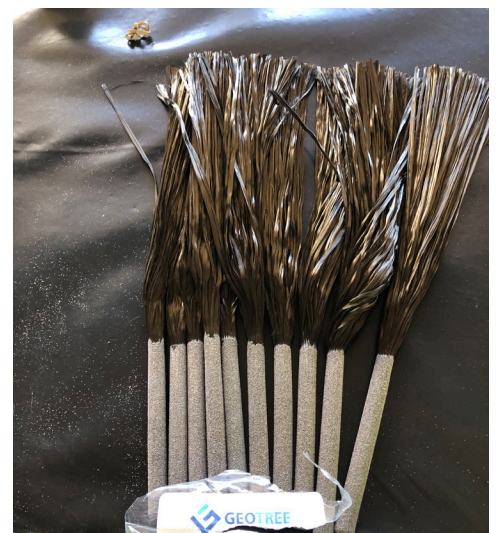
*RenewWrap Anchors*

This was used alongside RenewWrap EMBED anchors which were pre-cured for insertion into the drilled holes. This pre-curing allows for smaller holes to be drilled into the concrete which in turn reduces the epoxy usage during embedment. By being pre-cured, the anchors allow quicker placement, proper splaying of the fiber bundled, and ultimately speeding installation.
