AVT™ EZ VALVE®

Restores Water Treatment Plant Main

CASE STUDY: Strasbourg, Northeast France

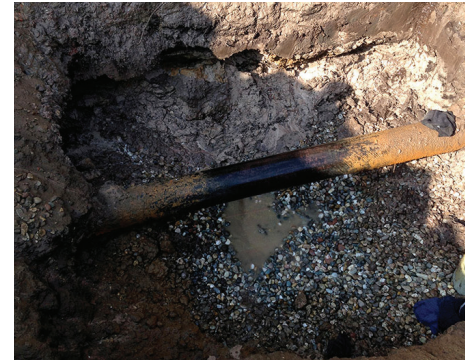
Excess Water is drained, pipe is thoroughly cleaned and prepped for valve body.

The project began with a site assessment that allowed experts to locate the problem area and excavate it to evaluate the damage. Once the decision was made to install an 8-inch (200-mm) AVT EZ Valve to provide a control point to allow a shutdown, the excess water was drained from the area to allow access to the installation team.

Working with local distributor Gutermann SARL, AVT began the installation. The first step was to thoroughly clean the pipe and prepare it for the installation of the valve. Next, the valve body was secured to the pipe, and the cutting tool was attached and leveled in preparation to cut the damaged portion of pipe. With the valve body properly place, installers cut a 120° slot cut across the top of the pipe. When the cutting was completed, the team closed the temporary knife gate and lowered the bonnet into place and secured it to the valve body. At this point, the wedge gate was lowered to create a driptight seal.

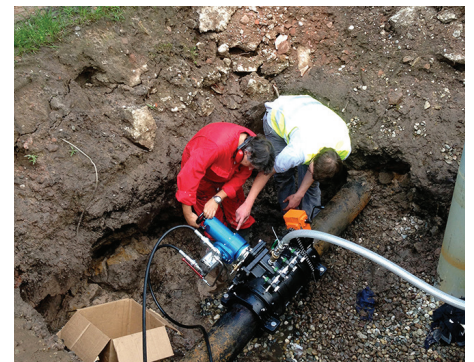
Cutting tool is leveled and prepped for milling.

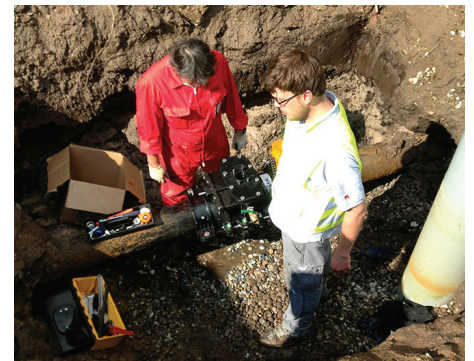
Wedge gate is lowered and drip tight seal is created.

The installation team was able to restore line integrity in only 1 hour with little disruption to the site and no disruption to service. The AVT EZ Valve stopped the leak, and the bonnet will allow continued reliable flow and easy maintenance on the line.
