Tim Mally, CSNRI, USA, explores the benefits and implementation of composite repair systems for crack-like defects in pipelines.

PIPELINE INTEGRITY

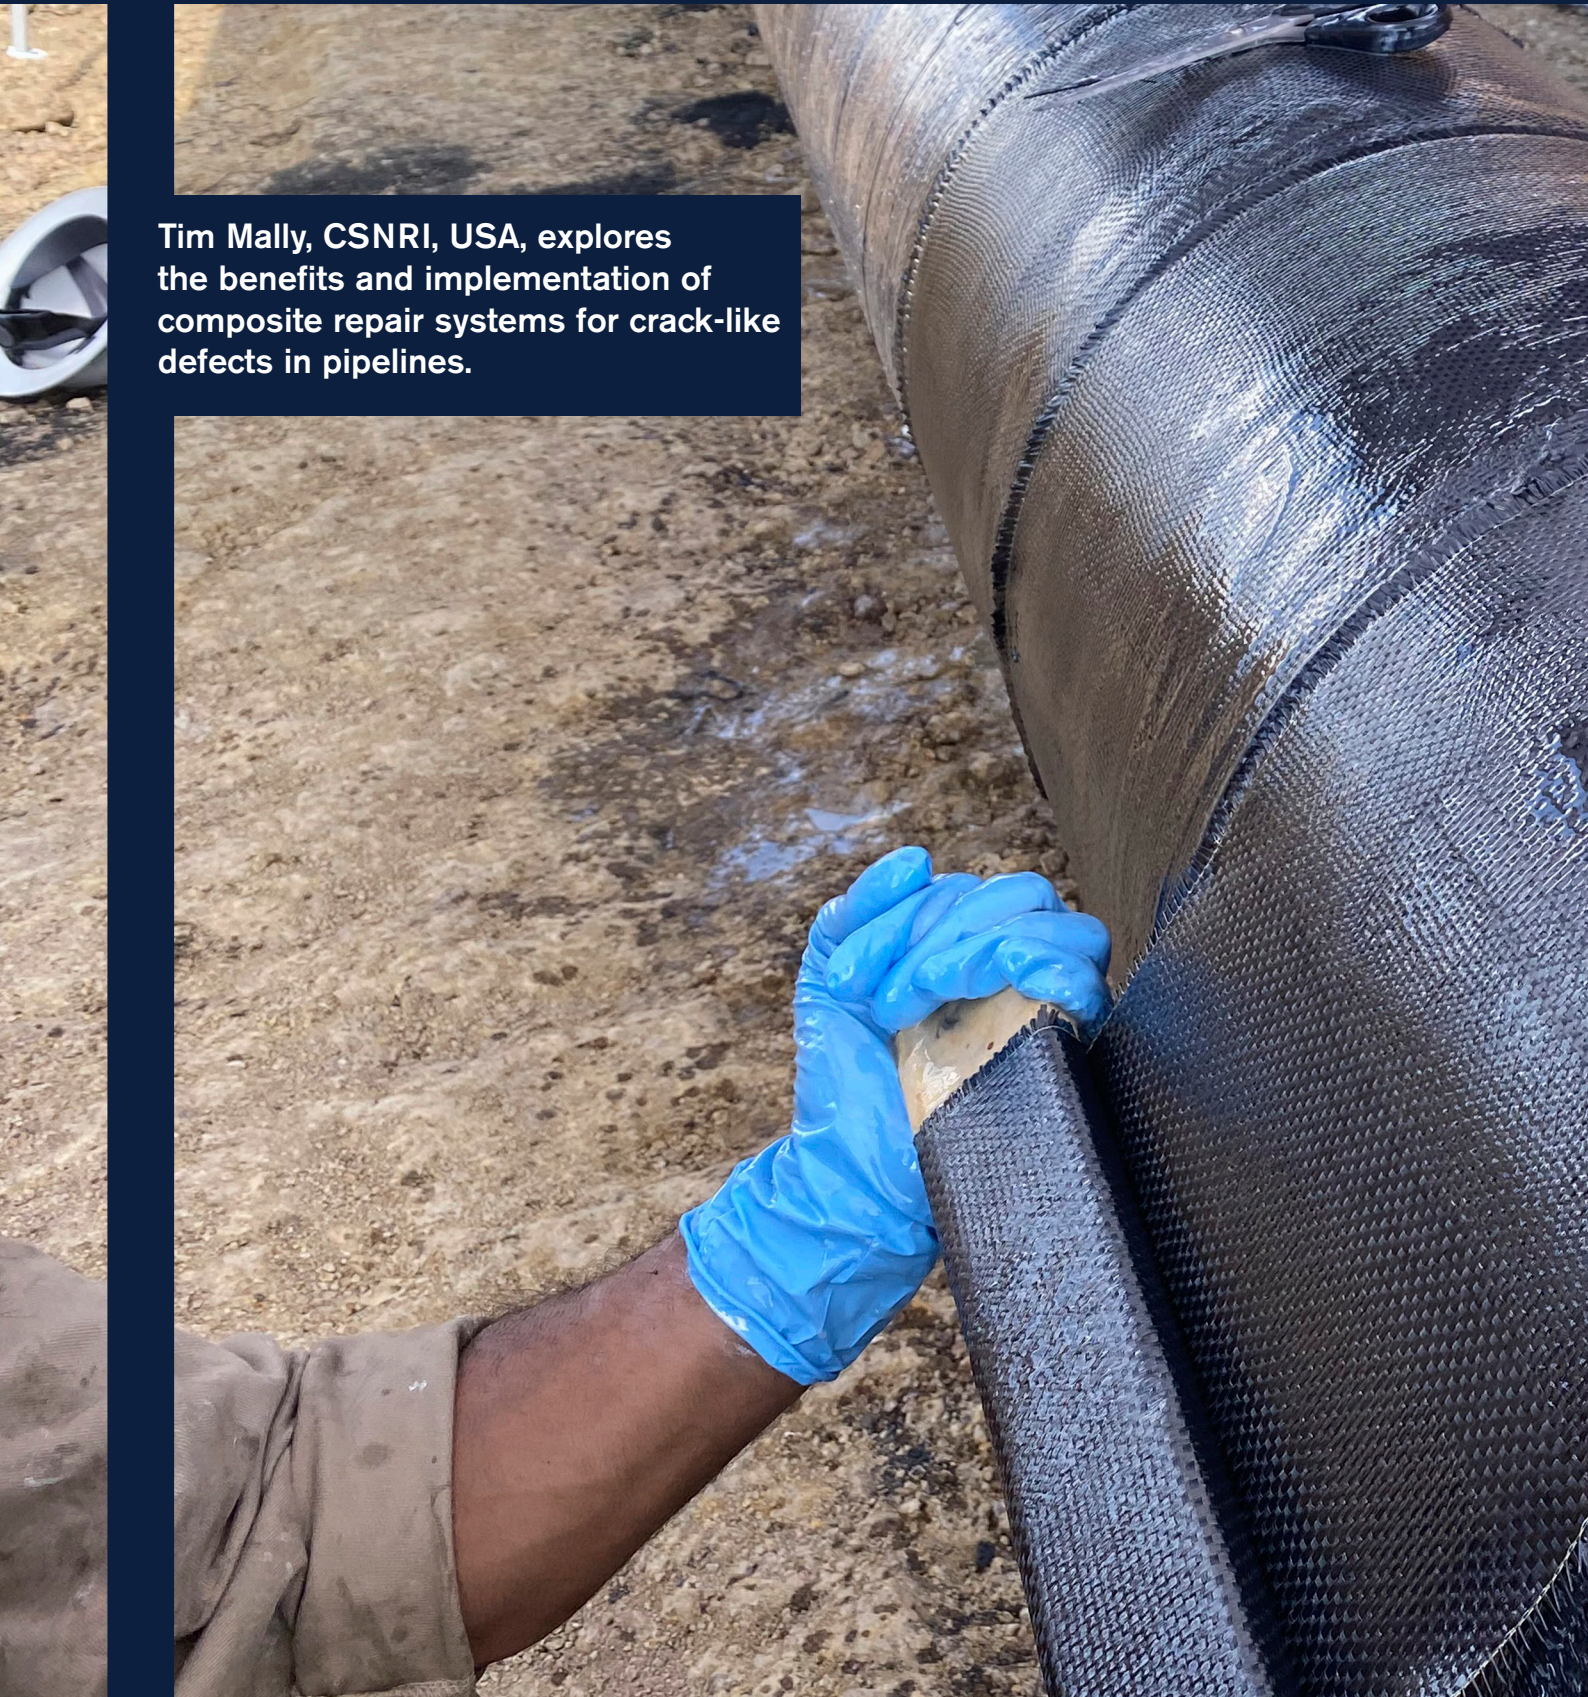
A close-up view of a person's hands, wearing blue gloves, applying a yellowish adhesive to a black, woven fabric repair material. The fabric is being wrapped around a large pipe. The background shows a dirt and sand trench.

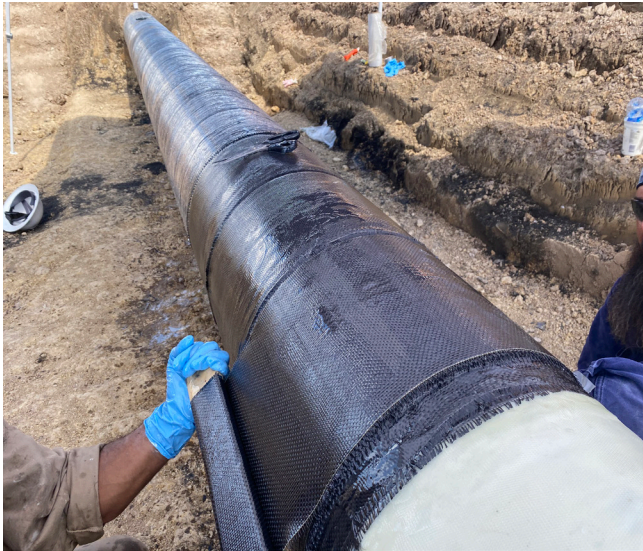
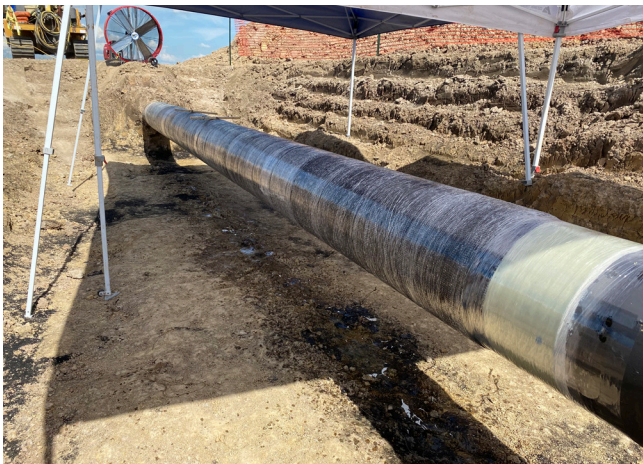
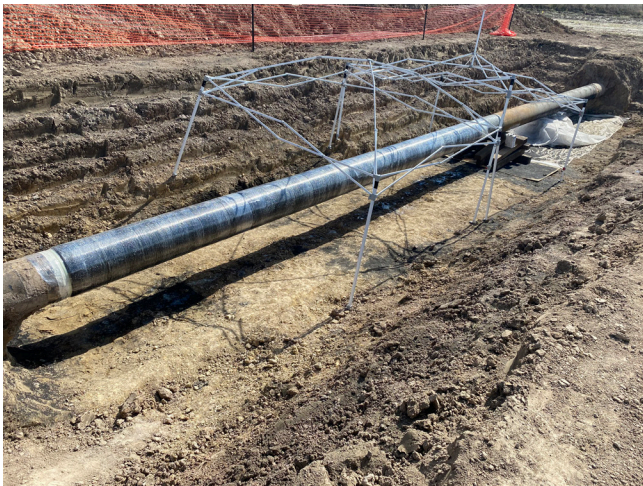
Figure 1. Atlas has been used to permanently reinforce crack-like defects on this 16 in. pipeline.

For the operators that have invested in the validation of composite repairs for crack-like defects, the rewards have been enormous. One pipeline company in particular operates an ethylene pipeline, which cannot be welded on due to the risk of auto decomposition of the ethylene and the threat of explosion due to the presence of any additional heat. This same pipeline was manufactured with LF-ERW welding methods, and an inline inspection tool discovered the presence of several crack-like defects in the seam weld that needed to be addressed. After a grueling testing programme, the Atlas demonstrated a superior ability to reinforce these crack-like defects over other composite systems and a bolt-on clamp. Based on the results of the testing programme, the pipeline operator decided that the Atlas was appropriate as a permanent repair for these anomalies.

In the field, installation crews worked around the clock to install dozens of Atlas composite repairs within a matter of weeks. Keeping close communication with the excavation contractor, the installers moved from site to site and were able to install the composite repairs within only a couple hours, and top coat and backfill was able to be accomplished the same day. The composite repair was flexible to on-site working conditions, able to be installed in hot and humid weather and in challenging terrain. Able to be installed by field labourers, it also saved money as welding-level labour was not required. Without any hot works near the pipe, the crews were safe from explosion risk through the entirety of the project. Once the last ditch was closed, the pipeline integrity group was able to breathe a collective sigh of relief knowing that their pipeline was permanently reinforced with a proven technology that did not require any welding.

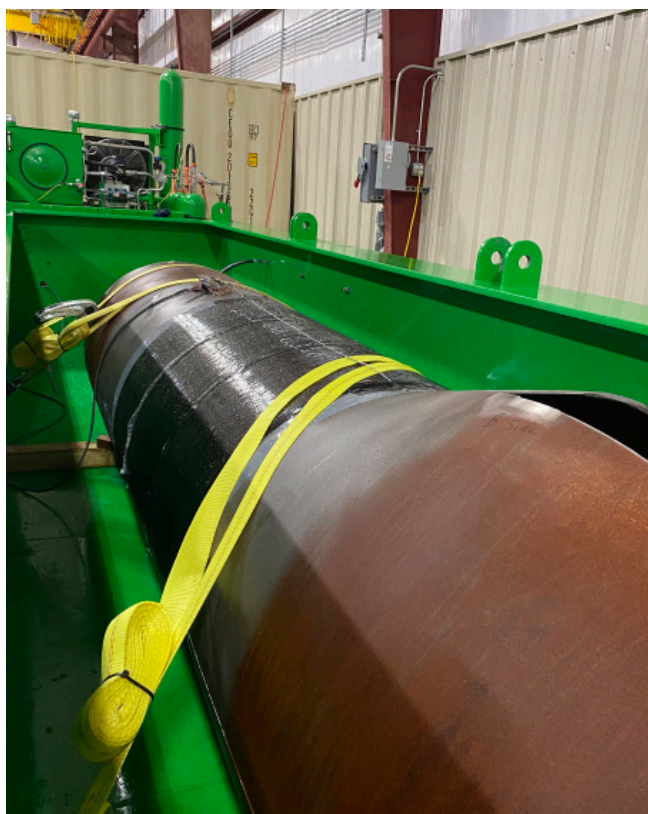
Figure 2. Atlas was validated on seam weld defects manufactured on full-scale spool tests.

At a third party testing laboratory, crack-like defects up to 75% in depth and up to 10.2 in. in length have been reinforced with Atlas, which has had a reliable engineering analysis completed to determine the appropriate amount of thickness and length. The diameter of pipes with these defects have ranged from 8 - 36 in. Many of the pipes had LF-ERW seam welds with low fracture toughness, mimicking a “worst-case scenario” of what could be found on an actual anomaly in the field. Each repaired pipe was then tested either to rupture or with pressure cycling until failure. As can be seen in Figure 2, Atlas has been successfully tested as a permanent repair for crack-like defects..
