NASSCO BERTHS 3 & 4 PIER STRENGTHENING

Location: San Diego

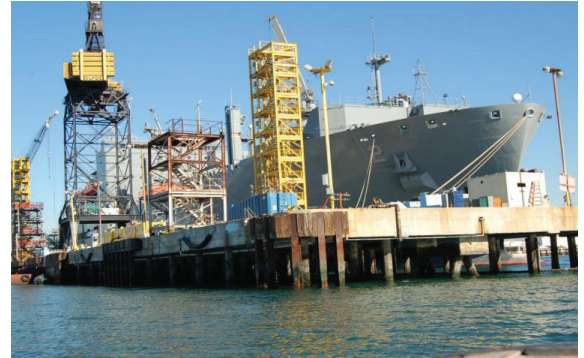
The 90 ton gantry crane in the photo above, is being supported by a 50 ton rated pier. Although the crane is not typically fully loaded, the pier experienced some overloading from time-to-time.

The beams directly below the crane rails required both shear and flexural enhancement to accommodate the service loads. Fibrwrap Construction provided a design-build proposal based on the engineers performance requirements.

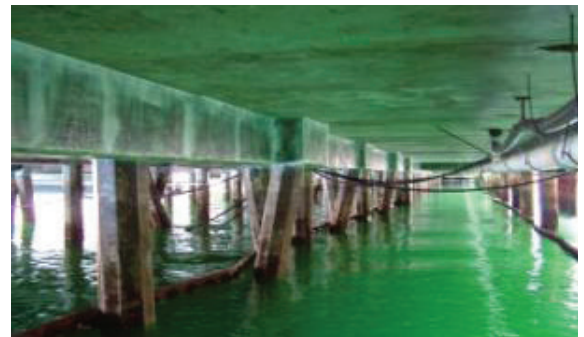
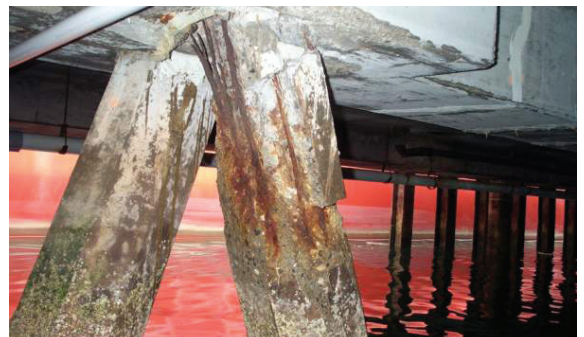
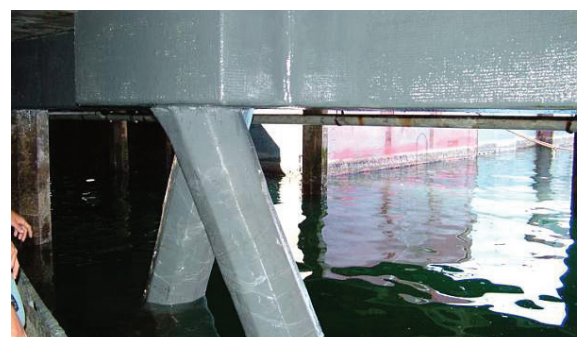
Only a few piles needed repairs. The batter piles pictured had to be rebuilt to regain their shape and stiffness prior to wrapping. The concrete repair included the use of The TYFO® CIS corrosion inhibitor. The TYFO® SEH-51A System was installed using the TYFO® SW-1 epoxy so that the jacket could cure in the bay.

The work was performed from floating platforms and had to be coordinated with the tides in order to get under the pier.

The TYFO® SW-1 epoxy was also used as a finish coat on the beams in order to protect them from the rising tides.
