# AcidShield Restores Original Design Strength to MIC-Damaged Pipe at Chile Refinery

Chile

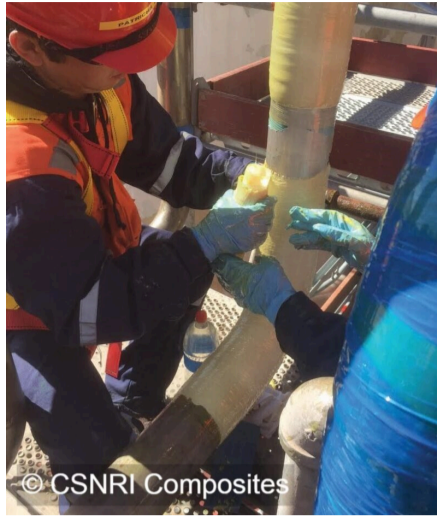
*Field-saturated AcidShield was applied quickly to corroded areas throughout the system.*

First, crews used an MBX bristle blaster to achieve the required minimum 1.5 to 2.5 mil anchor profile. Then, using CSNRI's patented Resinator® field-saturation machine, the AcidShield composite fiber was wetted with epoxy and quickly wrapped around the compromised weld joints. The Resinator is a custom-engineered, saturation machine designed for use with CSNRI's field-saturated systems. Critical to proper installation of wet layup, field-saturated composite repair systems, the Resinator controls the resin-to-cloth ratio ensuring the correct strength repair is carried out. The job required minimal manpower and no heavy equipment to achieve complete restoration of the corroded areas.

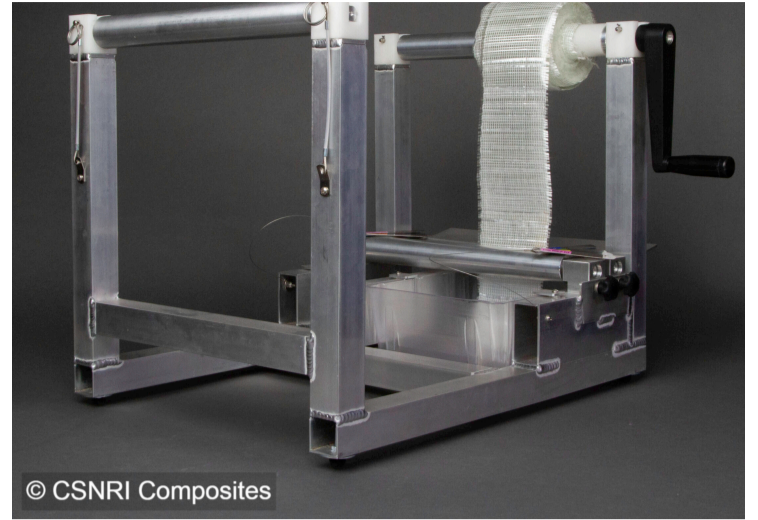
*The Resinator® saves time and money, especially on large projects, allowing installation technicians to saturate at a much faster rate than via hand saturation techniques.*

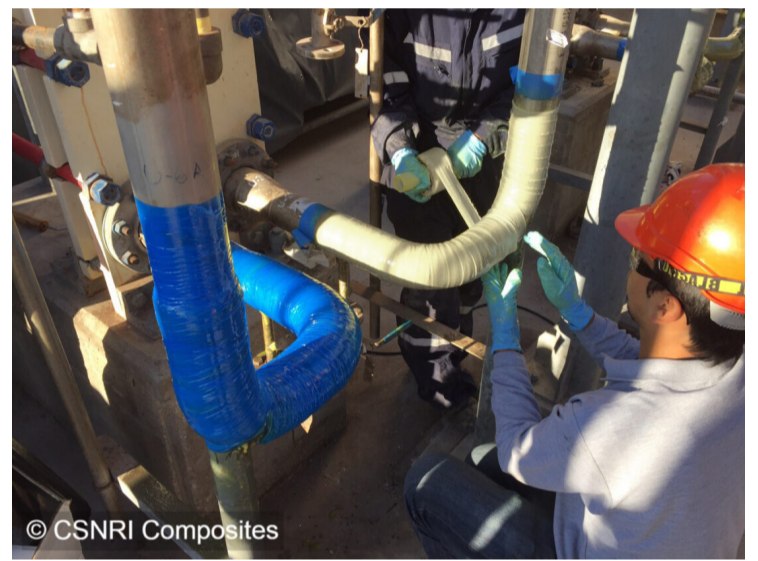
*AcidShield restored the damaged stainless steel pipe to original design strength without interruption of operation.*

## Results

The composite installation was performed without incident, while the facility maintained full operation. The repair restored the process lines to original design strength. The MIC assault was controlled, mitigating the risk of future failure. The asset owner is extremely pleased with the outcome, and looks forward to utilizing CSNRI composites and site support for future projects.
