ScarGuard Enables HDD Installation Under the Oneida River

New York

Pipe Details

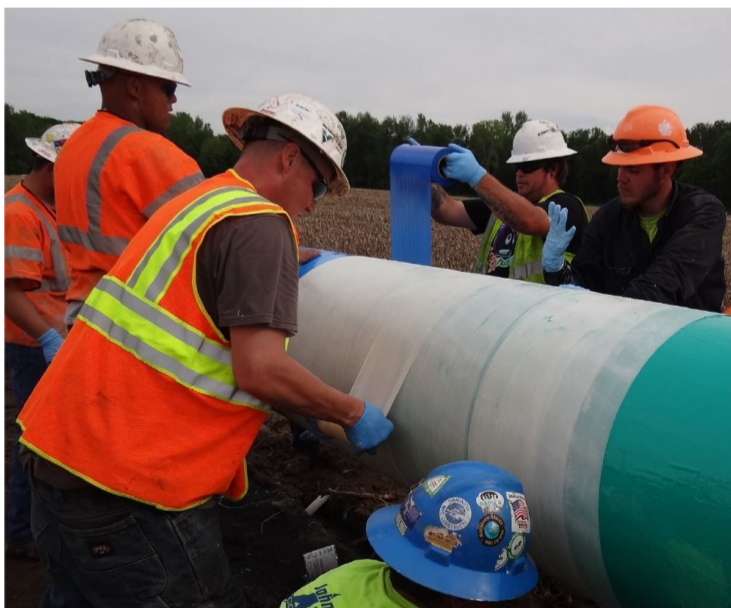
With a successful test pull determined the ARO could withstand the abrasion from the cobble.

The first run set the tone for the project. Not only was the carbide cone lost as the section of pipeline was being pushed through the cobble, but the coating was scarred down to wall loss. A site engineer assessing the damage suggested the scarring on the pipe had resulted from the cone dragging at a tangent along the line. While this seemed likely, the team could not locate the carbide cone, and drilling another hole would be cost prohibitive, amounting to approximately \$1.5 million.

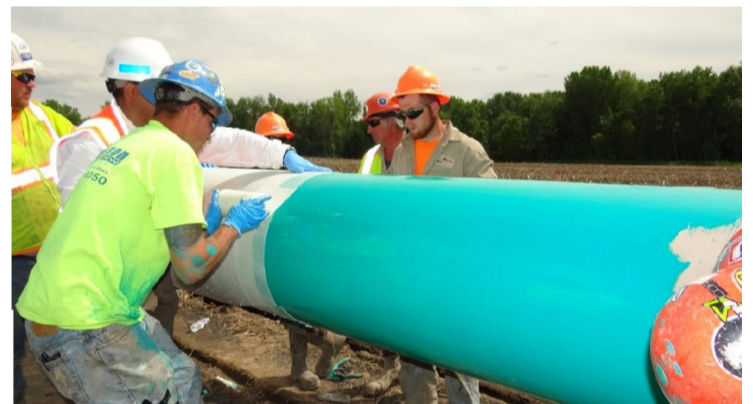
The installation team prepares a 300-ft (91-m) section of pipe with ScarGuard for a test pull.

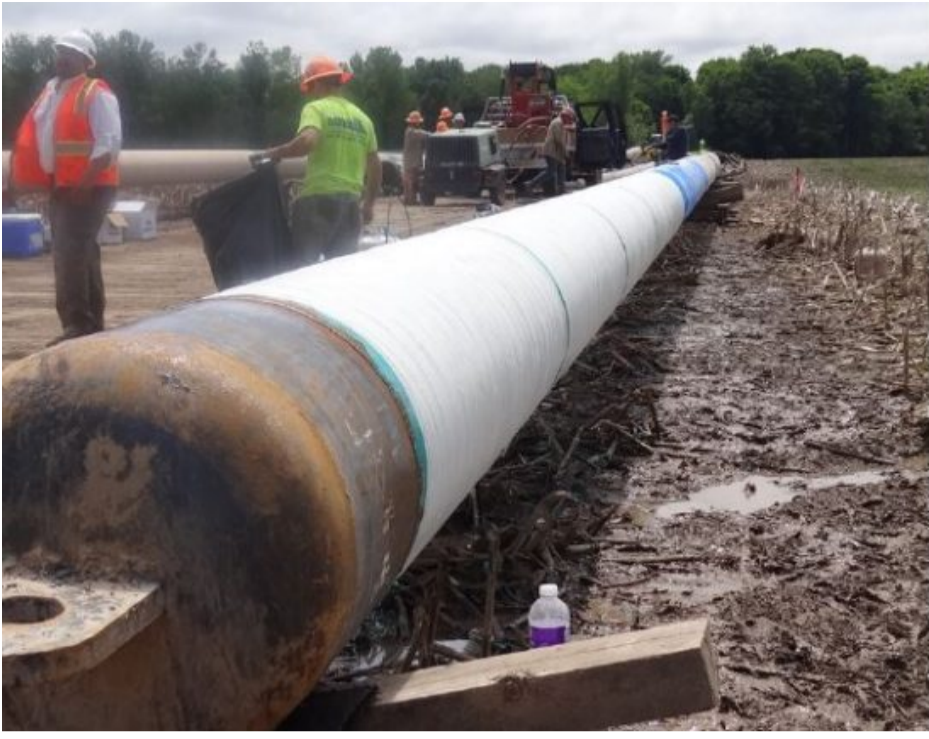
The field team wrapped 300 ft (91-m) of the line and every weld with ScarGuard to provide maximum protection during the installation, enabling the successful HDD installation of the full 1,200 feet (366 m) of pipe.

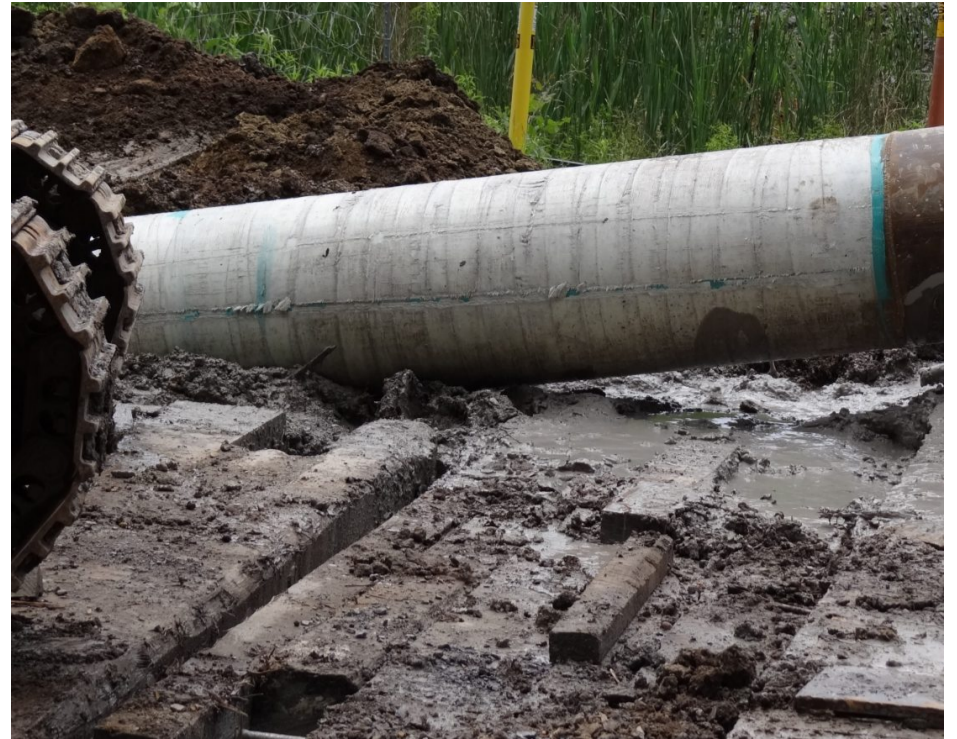
A successful test pull proves that ScarGuard is equal to the task of protecting the pipe from abrasion from the cobble.
