RENEWWRAP®

Carbon Fiber Strengthening System

Case Study Reinforced slab and beam, Southeastern U.S.

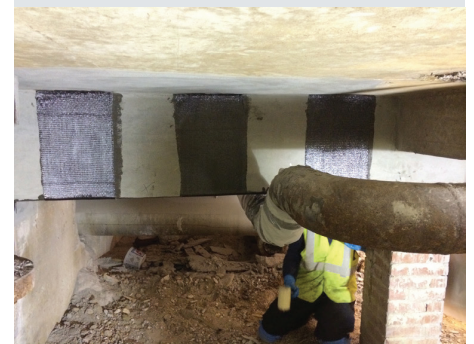
More than 100 years after initial construction, a textile plant in the Southeast serving the booming automotive industry discovered it needed to rehabilitate portions of the structure supporting the main manufacturing floor. Years of exposure to the hot, humid manufacturing environment and chlorides used in the manufacturing process had taken a toll on reinforced concrete beams and columns supporting the concrete slab. Significant corrosion-related damaged had weakened the beams and columns.

Once OCS completed shoring installation they began making repairs to the beams by removing the loose concrete with small chipping hammers, cleaning and replacing, where possible, the corroded reinforcing steel, and restoring the cross-section of the beam with traditional repair mortar. After the repair mortar cured, RenewWrap carbon fiber was applied to the bottoms of the beams to provide additional flexural strength and U-wraps were bonded to the sides of the beams to provide additional shear strength especially in locations where supplemental masonry columns had been constructed years ago to shorten spans.
