## RenewWrap FRP with EZ-Slit employed to reinforce Nicaraguan bank structure

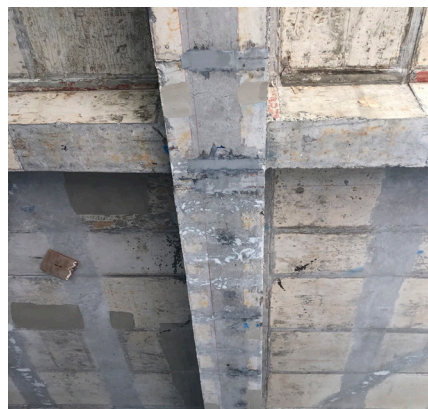
RenewWrap EZ Paste applied

The repair process involved clearing out the cracks and spalling areas before applying RenewWrap EZ Paste. This filled the bug holes and imperfections to the concrete creating a stable substrate.

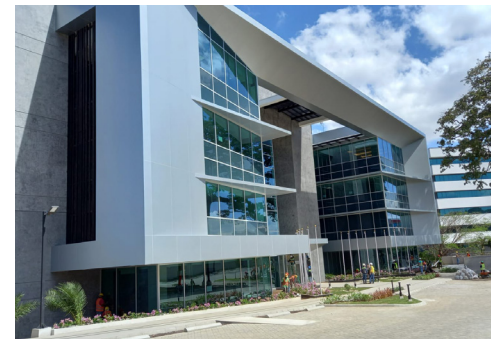
Outside of building
