GEOSPRAY®

CASE STUDY:

CMP Culvert Centennial, Colorado

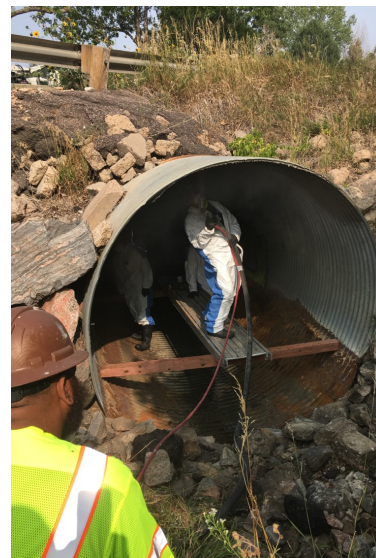
Due to the size of the culvert, GeoTree's GeoSpray geopolymer was hand spray applied.

Using specialized equipment, the Insituform six-man-team installed 2-inches of GeoSpray material to the interior of the 157-foot long culvert. Due to the large diameter of the culvert and challenging access, it was decided to hand spray versus using a spin-casting process. The flexibility of the GeoSpray material to be applied with either method allowed the contractor to choose the most efficient method for the unique aspects of the project. The entire install took just one-and-a-half-days, and the culvert was quickly placed back into service.

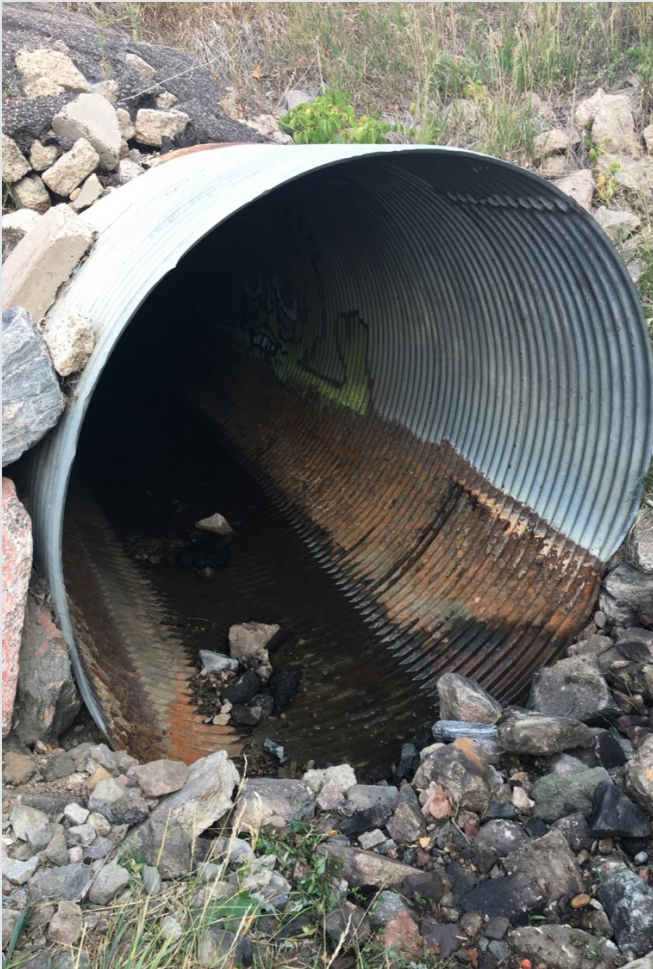
Before: Heavily worn culvert running under Cherry street and Forrest Drive in Centennial, Colorado that required rehabilitation

In the fall of 2019 after removal of sediment, SEMSWA (Southeast Metro Stormwater Authority) engineers carried out an assessment and identified heavy wear and abrasion to the metal of a 108-inch culvert.

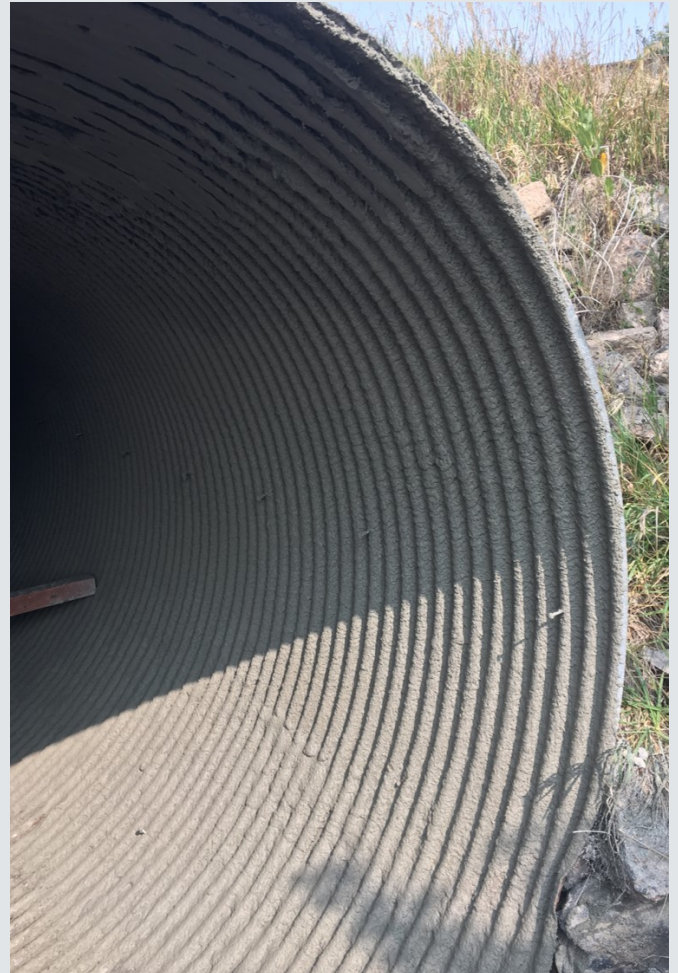
During: Application of GeoSpray takes the shape of the host pipe. Corrugations can be filled if desired to create more hydraulic capacity.
