## Textbook Rehabilitation of a Culvert using GeoTree GeoSpray

Tarheel Road, City of  
Charlotte, NC

**Application:** Culvert Rehabilitation

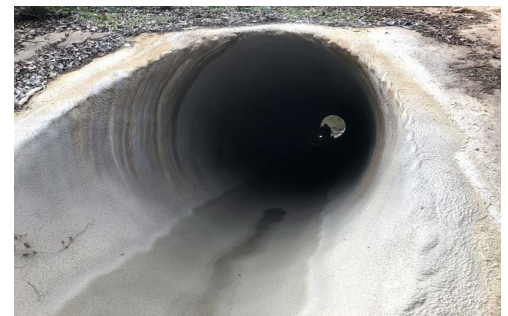
Completed GeoSpray installation.

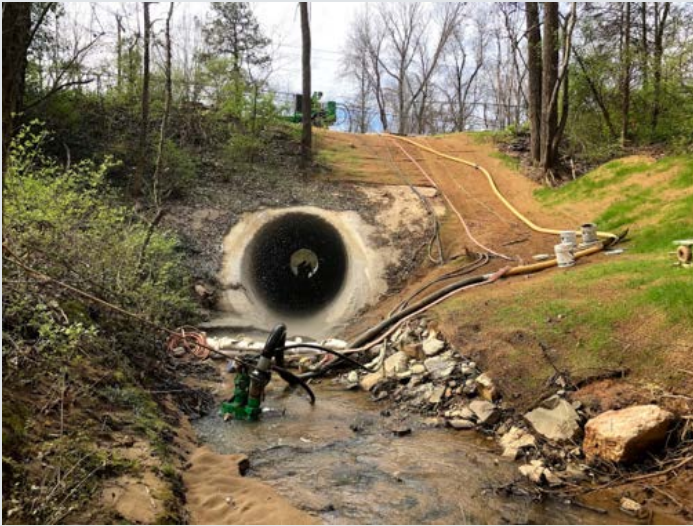
Bypass set up - Paw Creek is a live stream flow

The project was scheduled during the dry season when the live stream that runs through the culvert was at the lowest flow and was easily diverted with an external bypass while workers were required to be in the pipe.

Once the engineered design thickness was approved, a calculation was made regarding the required amount of GeoSpray and the team set about preparing the work site. The culvert conveys an active stream, Paw Creek, so in order to install the external bypass the team simply dammed up the creek with sandbags daily, dropped in a sump pump and pumped the water out and over the road into other side of the creek. They were able to easily release the water to flow freely at night. This gave the installers from IPR clear and simple access to the entire culvert and due to the large diameter, the crew was able to hand spray the entire culvert in 5 days.

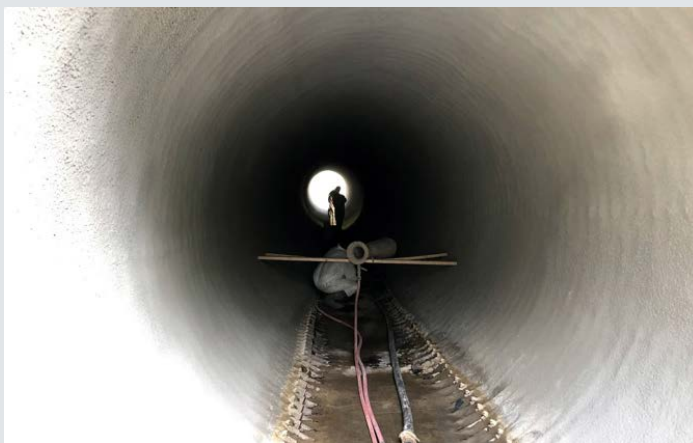
Bottom of pipe left until last for ease of install.

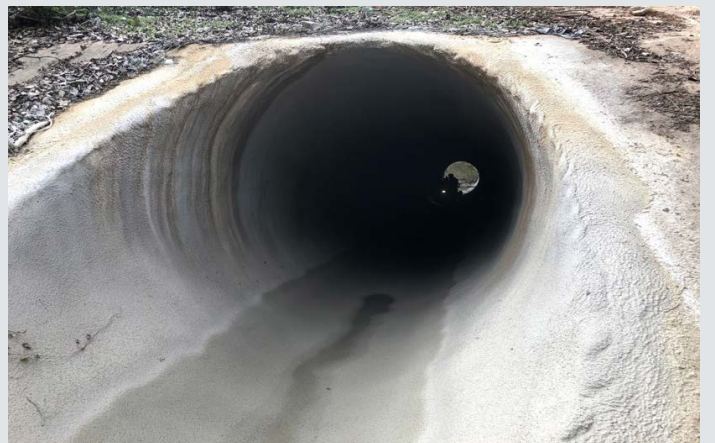
Completed installation of GeoTree GeoSpray.
