# GEOSPRAY<sup>®</sup>

## Geopolymer Mortar

## Lucas County, OH Sanitary Sewer Lining

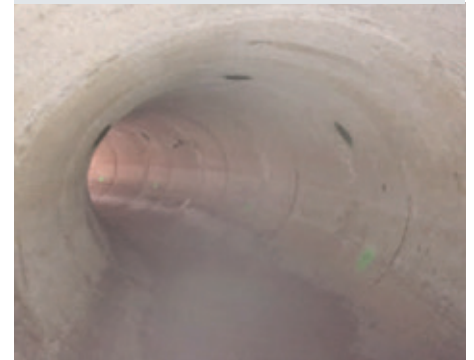
Completed project using GeoSpray mortar

The RCP had 1800 linear feet of pipe to be sprayed with the mortar to a two-inch thickness. This pipe is the main interceptor into the Lucas County Water Resource Recovery Facility (WRRF) in Waterville, OH. The alignment includes four 45° curves in the first 180 feet. Michels established a bypass system to divert wastewater around the work area and into the WRRF because the plant needed to remain in operation during the repair process. The bypass system ran across a footbridge above Interstate 24, and Michels drilled a 96-inch steel shaft to serve as an access for future work after the current project is completed.

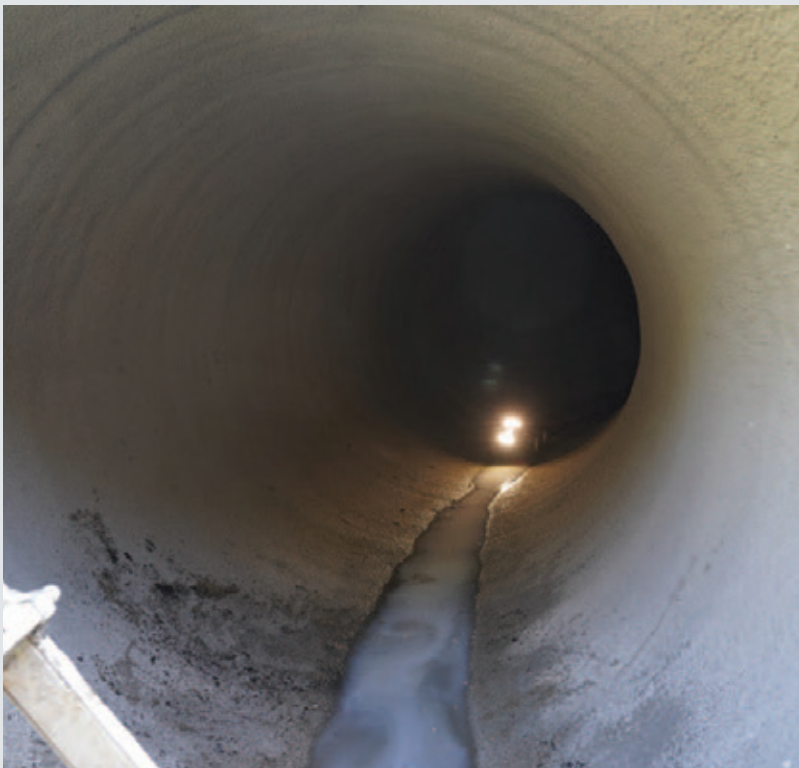
The project was completed in October 2018

The project was started in August and completed in October and the entire repair was done from a single entrance point. The county requested additional work to be completed, including several manhole structures and influent chambers at the plant. The next phase of the project is planned for bidding this summer with specifications for the same geopolymer mortar material based on the experience using GeoSpray mortar during phase one.

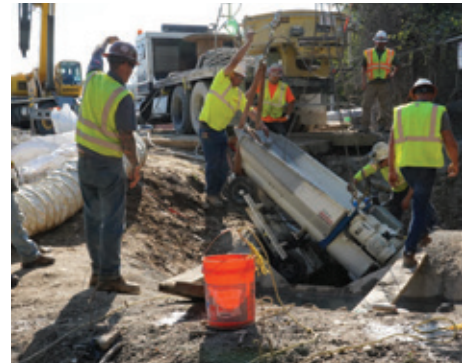
All work was done from a single entrance point at the project site

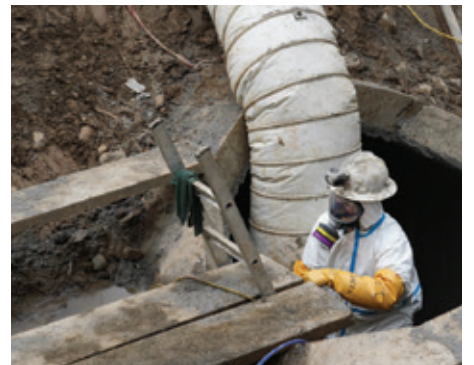
Bypass system installed to divert wastewater around the work area

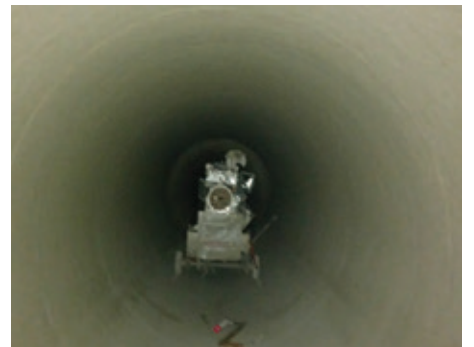
The pipe was sprayed with GeoSpray mortar to a two-inch thickness
